MONTHLY PROGRESS REPORT

MAY 2023

**Consultancy Services for Supervision & Monitoring of Performance-Based
Dredging Contracts with Maintenance Dredging and Installation & Maintenance of
Navigational Aids along the Navigational Routes under the Contract**

Bangladesh Regional Waterway Transport Project 1

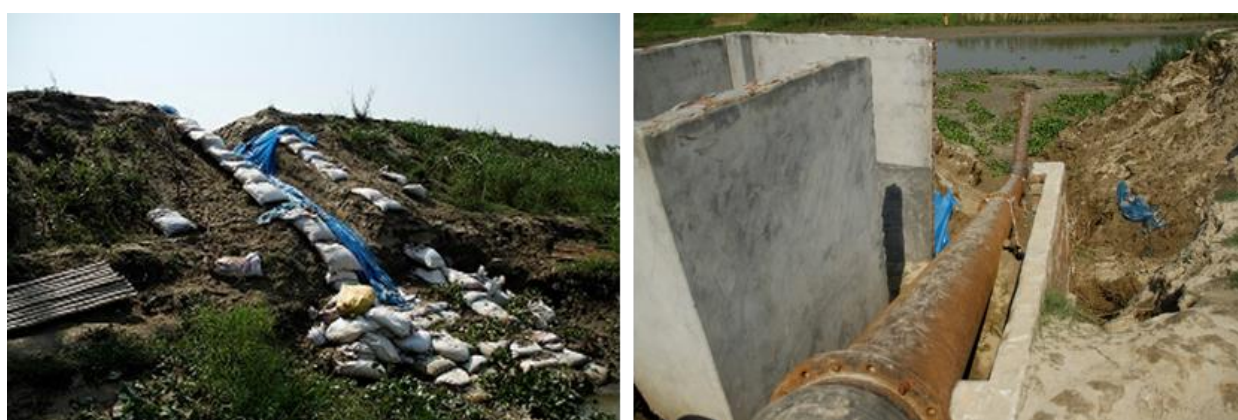
| Issues | Present Status (Lot 2) | Mitigation Measures | S1A Comments |
|---|---|---|--|
| Riverbank Erosion | During the reporting month, there was no issue was observed regarding riverbank erosion or flooding. | No mitigation measure is required. | Dykes constructed along the river bank for disposal of dredged materials are not maintained properly which caused breaches of the dykes and affecting the river bank to collapse and erode. See inserted pictures (Fig 3). |

Figure 3: Dykes constructed along the river bank. Disposal of dredged materials are not maintained properly which caused breaches of the dykes and affecting the river bank

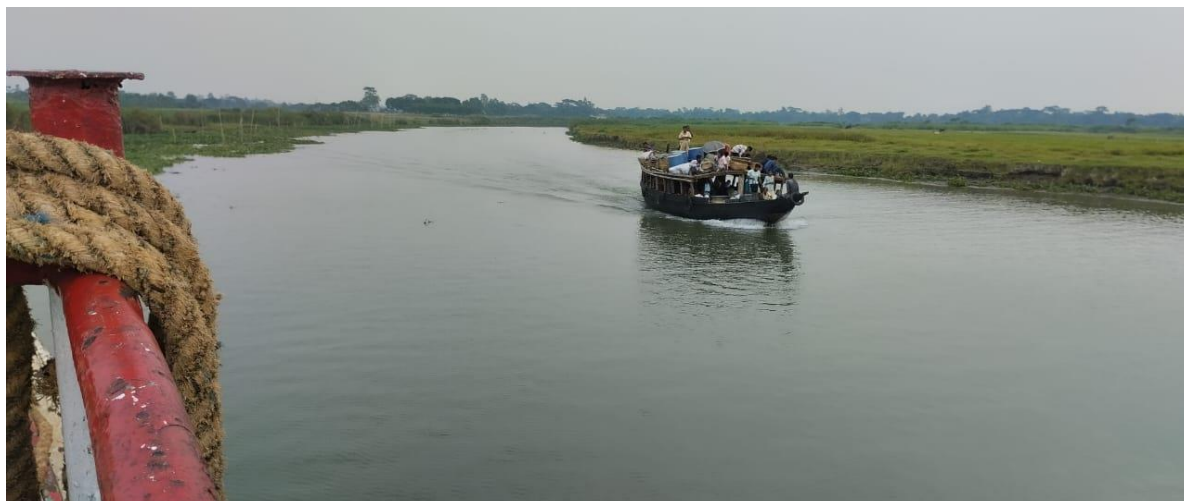
It has been observed & also known from various sources that a good number of Launch and Engine driven Country boat carrying huge number of passengers plying regularly in route 09, being dredged by contractor GULF-COBLA KARNAFULY JV

Figure 11: Different types of River Transport at Route 9 (Titus River), Solimganj Brahmanbaria.

Kindly arrange to advise the contractor GULF-COBLA-KARNAFULY JV to install adequate buoys as per IALA Marine

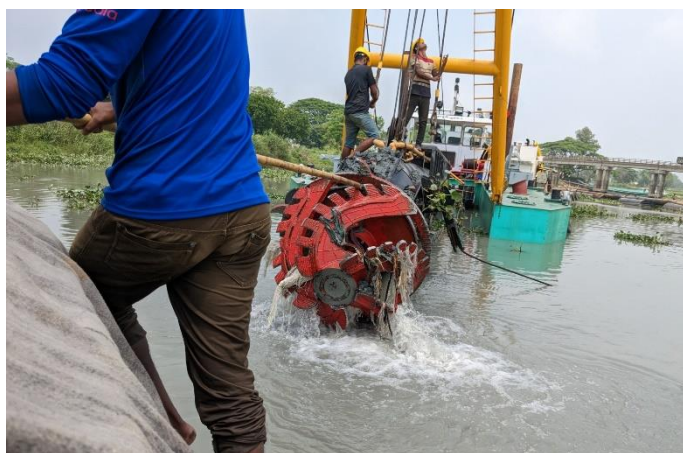
Figure 12: Lot 2, Route-09. (Bancharampur-Homna Loop), Solimganj, being dredged by Cutter suction Dredger Karnafuly-07

Buoys to be fitted in every Nautical Mile (1 nautical mile is equal to 1.852 kilometers) along the route 09.

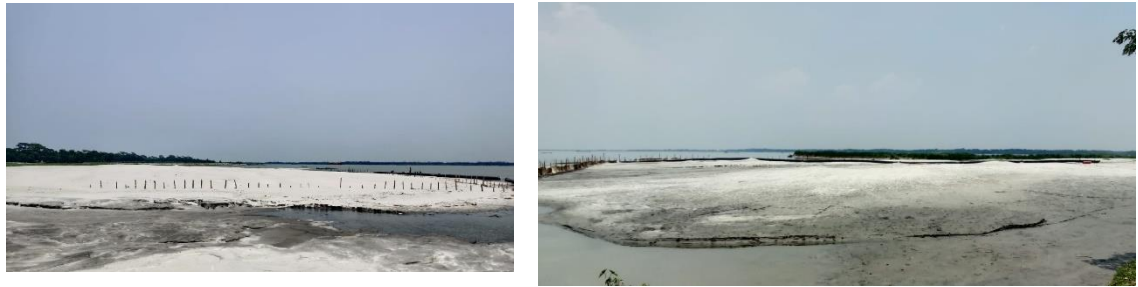
- (1) **R16-D1:** Area is 17,633sqm, Height is 3.5m (approx.) and estimated capacity containing 61,715.5cum spoils.

- (2) **R16-D2:** Area is 11,596sqm, Height is 3m (approx.) and estimated capacity containing 34,788cum spoils.

Figure 13: Dredge Material Disposal Area R 16D1 and D2

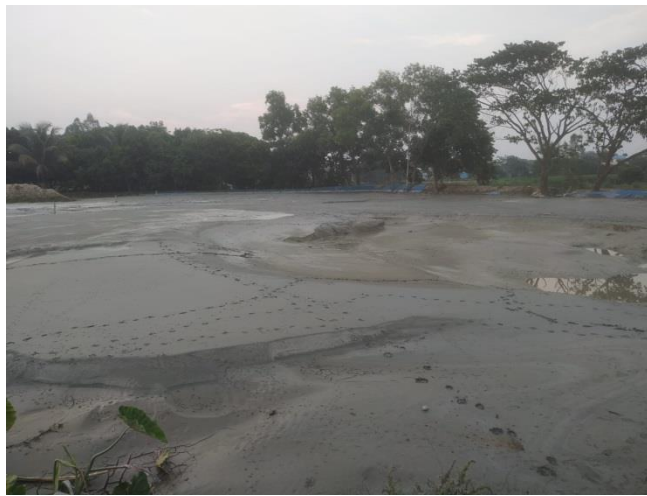
- (1) R09-D2: Area is 17,493 sqm; Height is 3.0m and estimated capacity containing 52,479cum spoils. It is completed.
- (2) R09-D5: Area is 5,888 sqm, Height is 3.0m and estimated capacity containing 17,664cum spoils. It is completed.
- (3) R09-D6: Area is 5707 sqm; Height is 2.5 m and Estimated capacity containing 14,267cum spoils. It is completed.
- (4) R09-D10: Area is 1,250 sqm; Height is 5 m and Estimated capacity containing 6,250 cum spoils. It is completed.

Figure 1: Photo of dredge material disposal area R09-D2

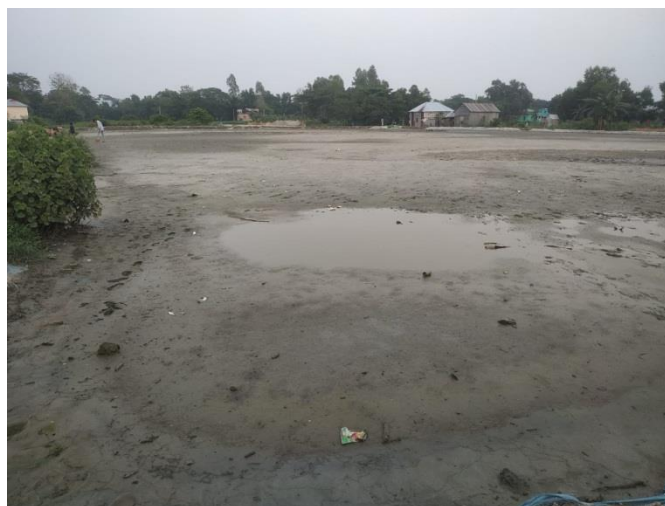
Figure 2: Photo of dredge material disposal area R09-D5

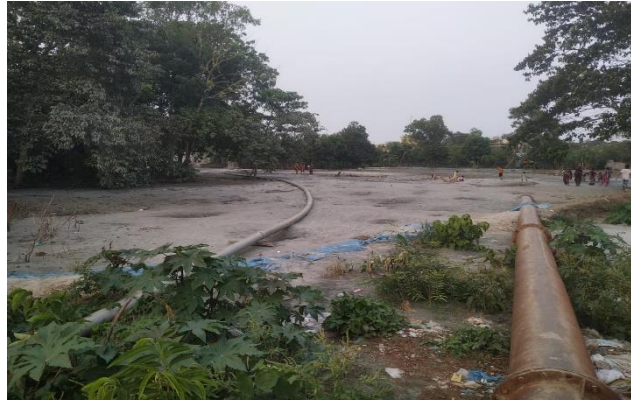
Figure 3: Photo of dredge material disposal area R09-D6

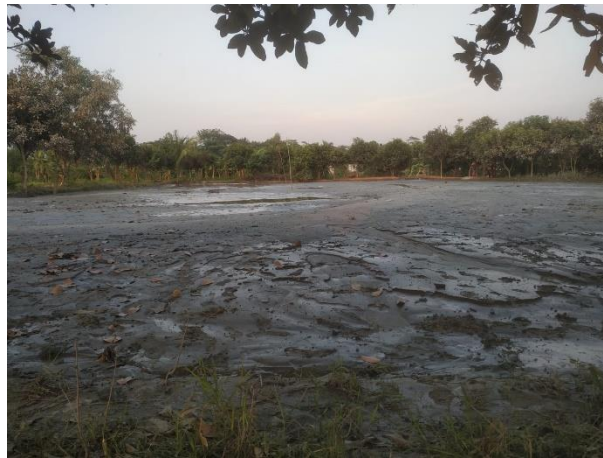
Figure 4: Photo of dredge material disposal area R09-D10
