Bangladesh Inland Water Transport Authority (BIWTA)

## MONTHLY PROGRESS REPORT MARCH 2023

**Consultancy Services for Supervision & Monitoring of Performance-Based  
Dredging Contracts with Maintenance Dredging and Installation & Maintenance  
of Navigational Aids along the Navigational Routes under the Contract**

**Bangladesh Regional Waterway Transport Project 1 (BRWTP-1)- S1A**

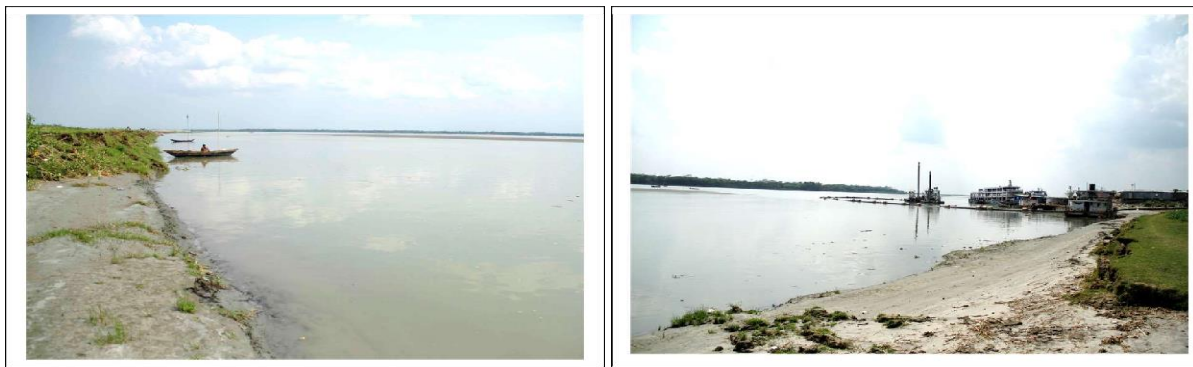
Figure 2: Proposed dredged material dumping site

The shallow left bank of the Maishkata River extending from the Patharghat Launch Ghat southward to almost 300 meters and delineated by the shoal developed almost 100 meters from the river bank (Fig. 2). This area is proposed for bunding and dumping of the dredged material.

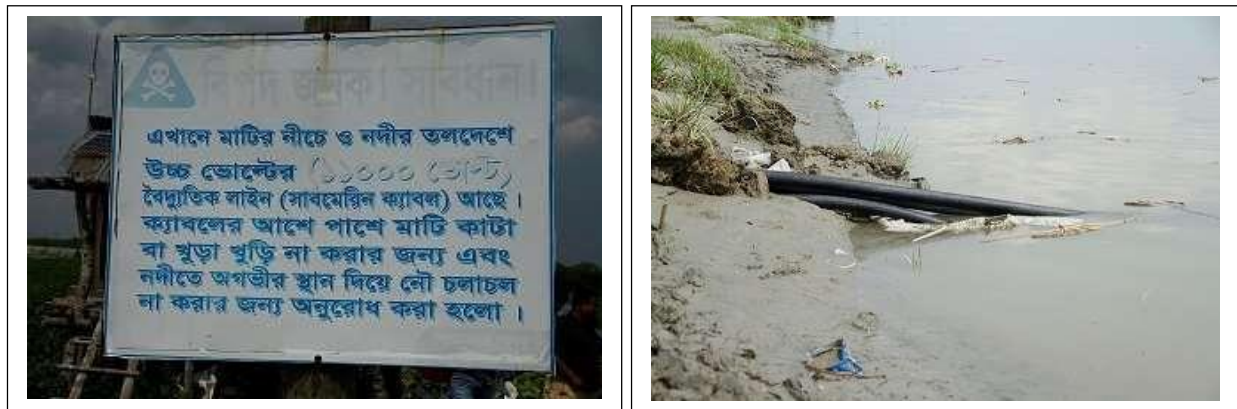
Figure 3: Underwater high-voltage cable within the proposed dumping site

The proposed site hosts a live high voltage underwater cable (Fig. 3) that presumably will pose hindrance to the dredging operation and dumping of dredged materials.

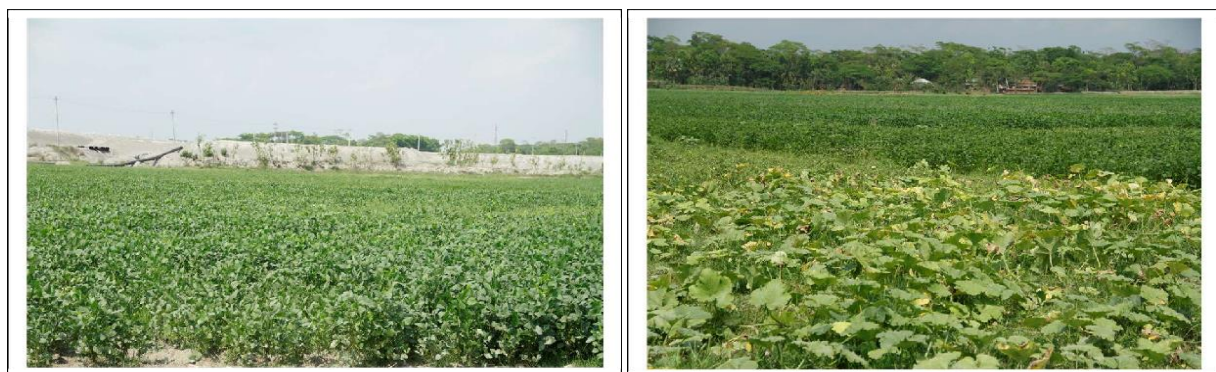
Figure 4: (Left) BIWTA dredged material dumping site; (right) seasonally cropped river bank area

On the left river bank adjacent to the proposed dumping site, the land is privately-owned, and fragmented with several owners who according to the enumerators are willing to lease the land for dumping dredged materials. However, there is evidence that BIWTA has leased land for dumping dredged material close to the proposed site under a different project (Fig. 4).

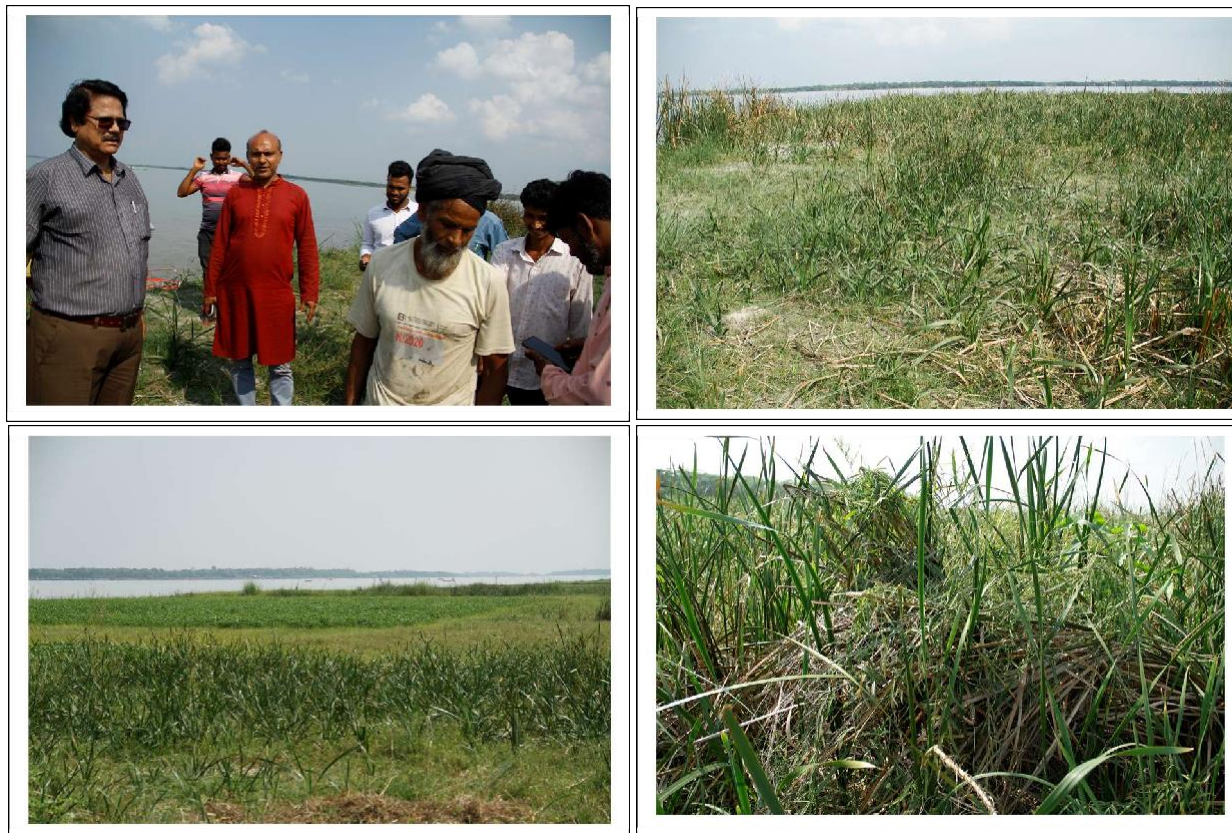
An alternate site located on the right bank and at the confluence was also visited by the team accompanied by the local Union Parishad Chairman and Members (Fig.5). The site is located about 1.8 km south of the Patharhat Launch Terminal.

The area supports reed land habitat that possibly would be 'khas' land with some encroachment, where local villagers are cultivating seasonal crops. However, according to the protocols as stated in the C-ESMP the reed lands habitat should not be altered or used for dumping.

**Figure 5: Alternate reed land site visited by the team members and local elected representatives**  
Some migratory and local resident fauna was observed during the site visit (Fig.6). A list of the species observed is provided in Table 2.

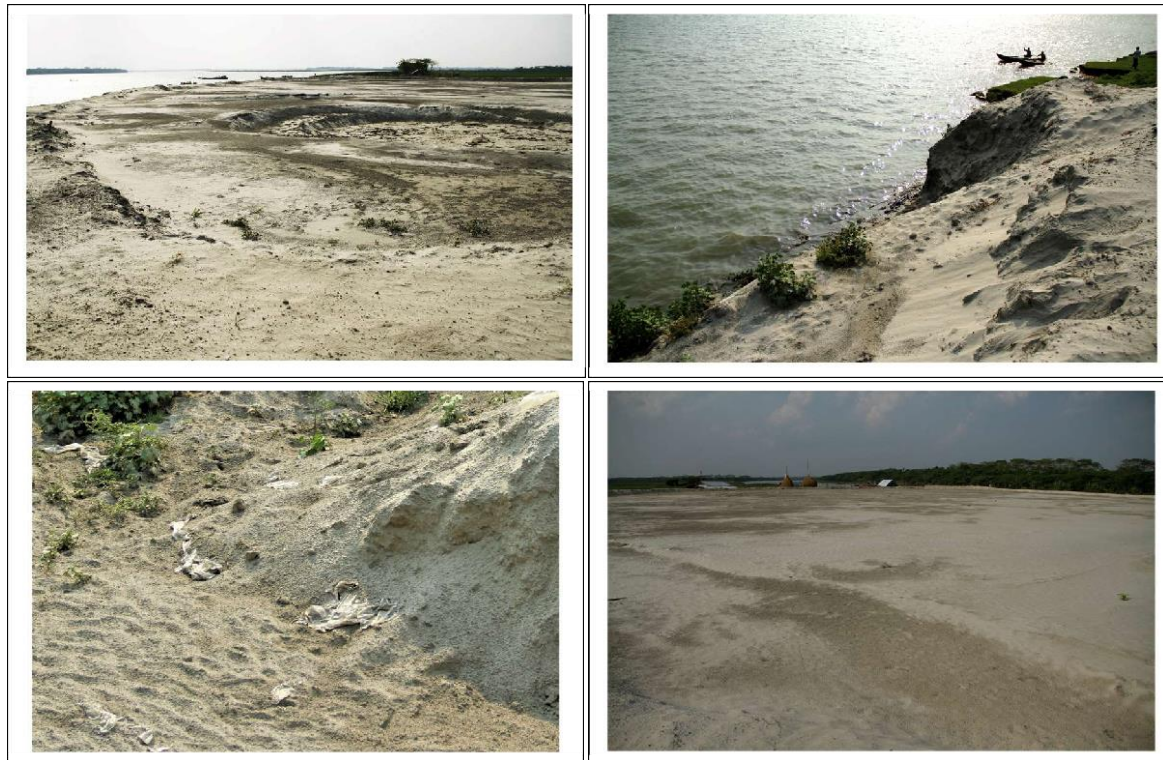
Figure 7: Present condition of the dredged material dumping sites – Dyke 1 of Route 21

The dredged material disposal sites–Dyke-1 and Dyke-2 was visited. The ‘bund’ of the dykes was in a bad shape and with breaches into the river as well as fragments of plastic sheets used to stabilize the ‘bund’ were lying around (Fig. 7). The dredged materials have settled within the ‘bund’, however by looking at the dyke boundary it gives a feeling of an orphan, whereas this should not have been the case.

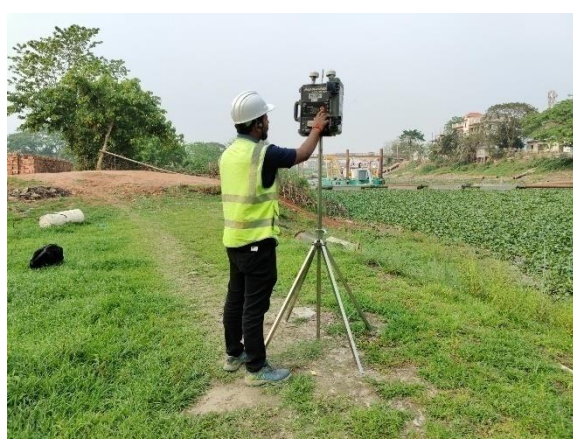
**Figure 8: Air quality monitoring for March 2023**

SI. No.	Sampling Station	Station Code	GPS Coordinates	Sampling Date
1	Solimganj ghat (R-9)	AQ-1	23°50'50.38"N 90°50'38.78"E	22/03/2023

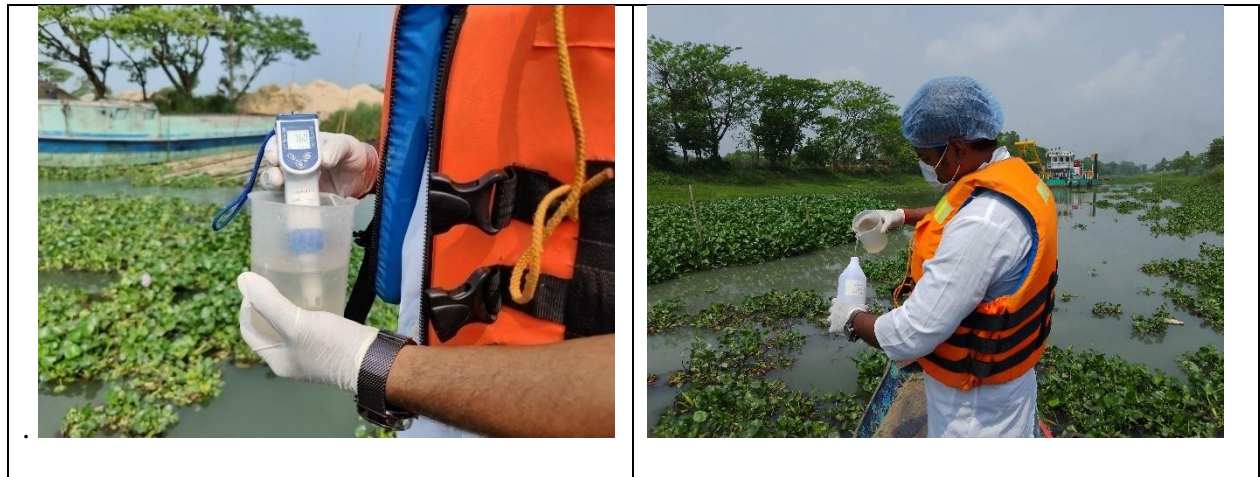
Figure 9: Pictures of Surface water sampling at Solimganj

**2.1.3.2 a Surface Water Quality Measurement:** In the month of March 2023, the status of surface water quality is measured by the contractors to determine the impact of dredging activities on

adjacent water bodies of the dredging sites. Results of the measurement of all locations was found within the national standard.

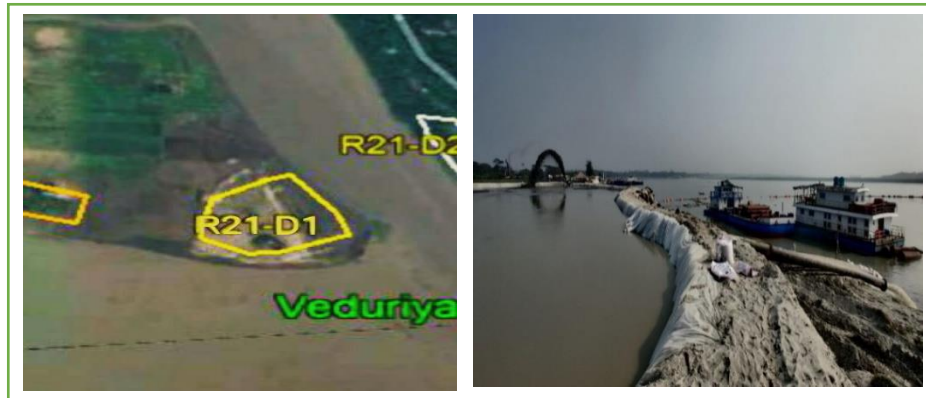
**Figure I: Photo of dredge material disposal area R21-D1**

Area (approx.)	12,729 m <sup>2</sup>
Height (approx.)	1.5m
Contain Capacity	25,000.0 m <sup>3</sup>

This is the private land owned by Mr. Md. Shahin Mia. It is a cultivable land and normally cultivated twice a year. This was filled on a rental basis. Proposed and safe filling height is

about 2.5m. This place is located in Mehendiganj Union under Mehendiganj Upazilla in Barisal district. This land is on the bank of Tentulia River and Route 21 from Laharhat to Bheduria. This place is on average 15m meter setback distance from the L/B bank of the river. Discharge pipe Nozzle is situated on top of dyke boundary wall and at an elevation of 6.00msl. Two outlets were used made of 8 numbers of pipe (dia 450mm) to drain water into the river.

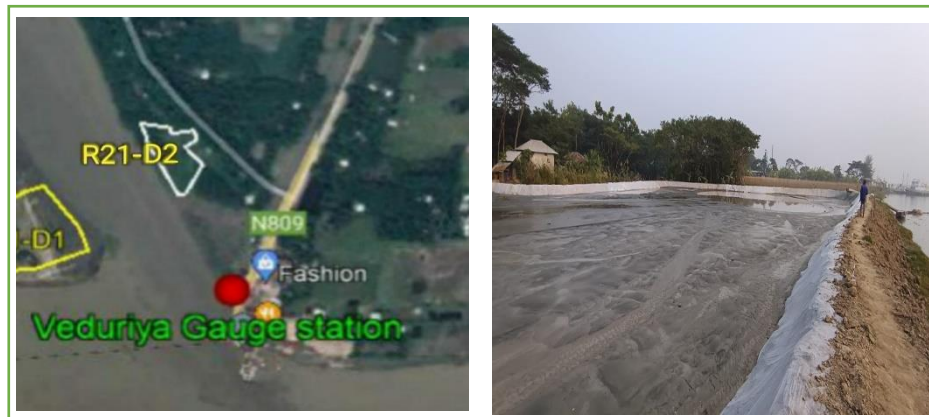
Figure ii: Location and Spoil Disposal plan for Block R21-D2

Discharge pipe Nozzle is situated on top of dyke boundary wall and at an elevation of 3.714msl. Two outlets were used made of 8 numbers of pipe (dia 450mm) to drain water into the river.

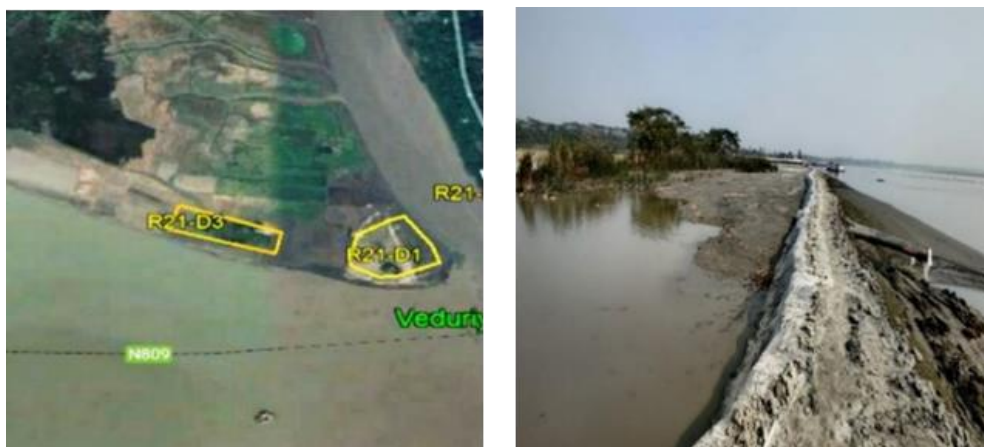
Figure iii : Location and Spoil Disposal plan for Block R21-D3

Area (approx.)	9,069 m <sup>2</sup>
Height (approx.)	1.6 m
Contain Capacity	14,692.0 m <sup>3</sup>

This is the private land owned by Mr. Md. Salam Fakir. It is a cultivable land and normally cultivated twice a year. This was filled on a rental basis. Proposed and safe filling height is about 2.5m. This place is located in Mehendiganj Union under Mehendiganj Upazilla in Barisal district. This land is on the bank of Tentulia River and Route number is Laharhat-Bheduria, Route 21. This place is on average 15m meter setback distance from the L/B bank of the river.

Discharge pipe Nozzle is situated on top of dyke boundary wall and at an elevation of 6.22msl. Two outlets were used made of 8 numbers of pipe (dia 450mm) to drain water into the river.

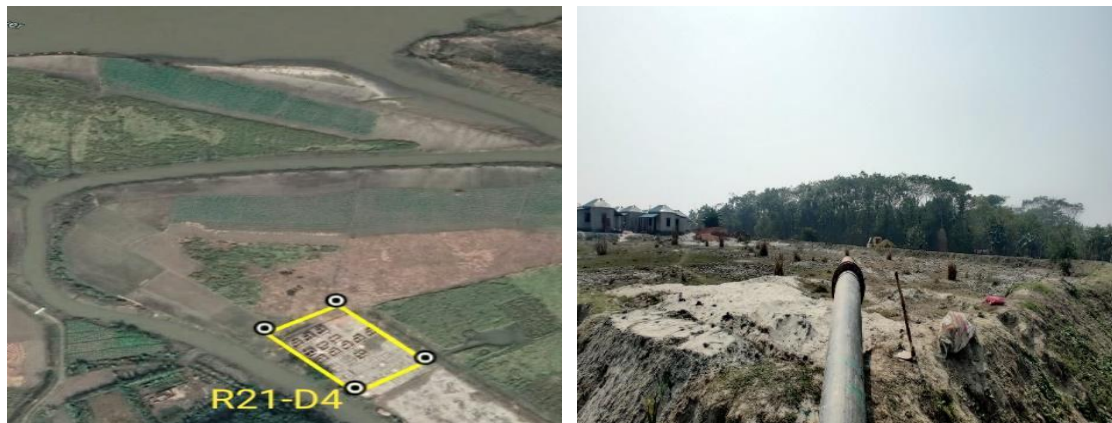
Figure iv: Spoil Disposal plan for Block R21-D4

Discharge pipe nozzle is situated on top of dyke boundary wall and at an elevation of 4.21msl. One outlet made of 4 numbers of pipe (dia 450mm) was used to drain water into the river.

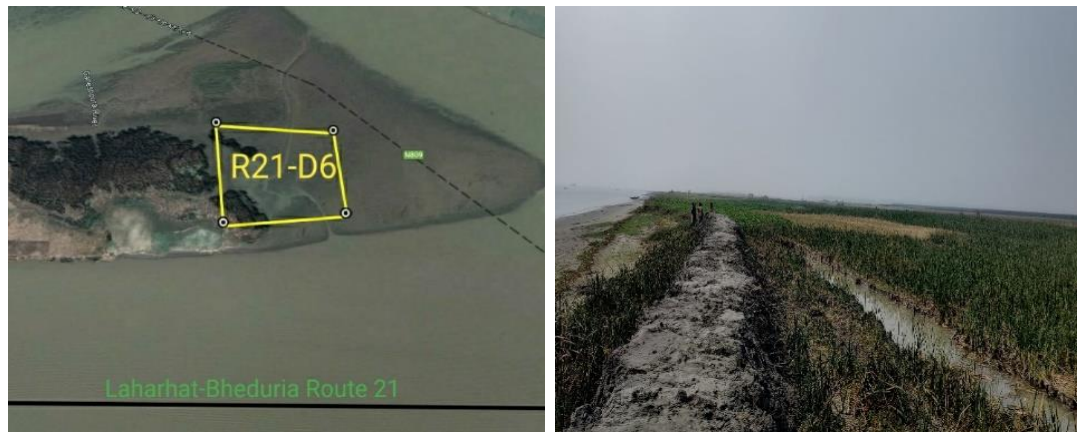
Figure v: Location and Spoil Disposal plan for Block R21-D6

This is the private land owned by Mr. Md. Narun Nabi Bhuiya. It is a cultivable land and normally cultivated twice a year. This was filled on a rental basis. Proposed and safe filling height is about 2.5m. This place is located in Ghagoria Union under Mehendiganj Upazilla in Barisal district. This land is on the bank of the Tentulia River and involving Laharhat-Bheduria, Route 21. This place is on average at a 20m meter setback distance from the L/B bank of the river.

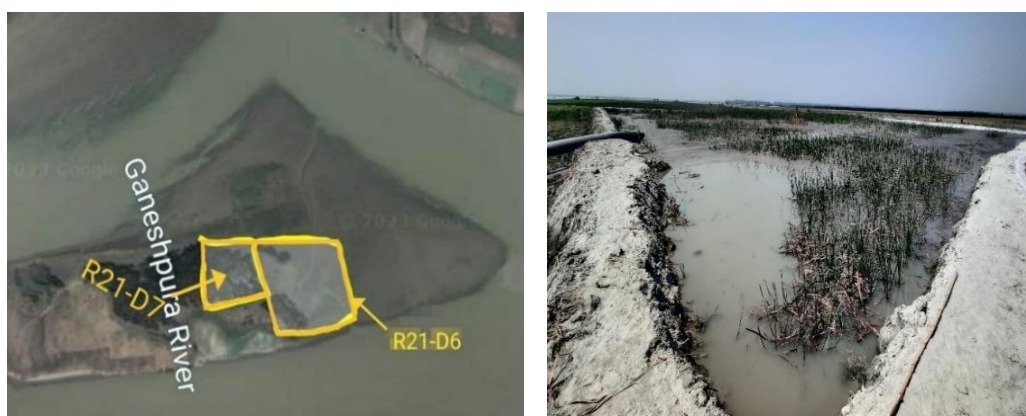
Figure vi: Location and Spoil Disposal Plan for Block R21-D7

This is the private land and owned by Mr. Md. Narunnabi Bhuiya. It is a cultivable land and normally cultivated twice a year. This was filled on a rental basis. Proposed and safe filling height is about 2.5m. This place is located in Ghagoria Union under Mehendiganj Upazilla in Barisal district. This land is located on the bank of Tentulia River and route number is Laharhat-Bheduria, Route 21. This place is on average 60m meter setback distance from the L/B bank of the river. Discharge pipe nozzle is situated on top of dyke boundary wall and at an elevation of 2.80msl. One outlet was used made of three (3) numbers of pipe (dia 450mm) to drain water into the river.

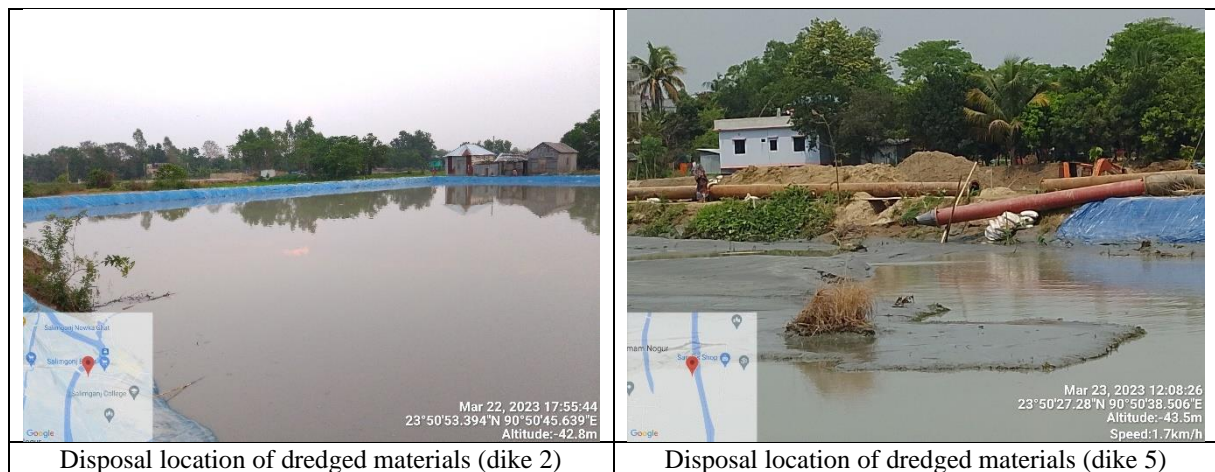
Figure viii : Dredged Material Disposal Site of Route 9 D2&D5

This is the private land and owned by Mr. Shiblu Mia, Md. Manjur Mahmud and Shima Akter. It is a cultivable land and normally cultivated twice a year. This was filled on a rental basis. This place is located in Tejkhali Union under Bancharampur Upazilla in Brahmanbaria district. This land is on the bank of the Titas River and Salimganj to Homna loop, Route 09. This place is on average 150m setback distance from the R/B of the river.

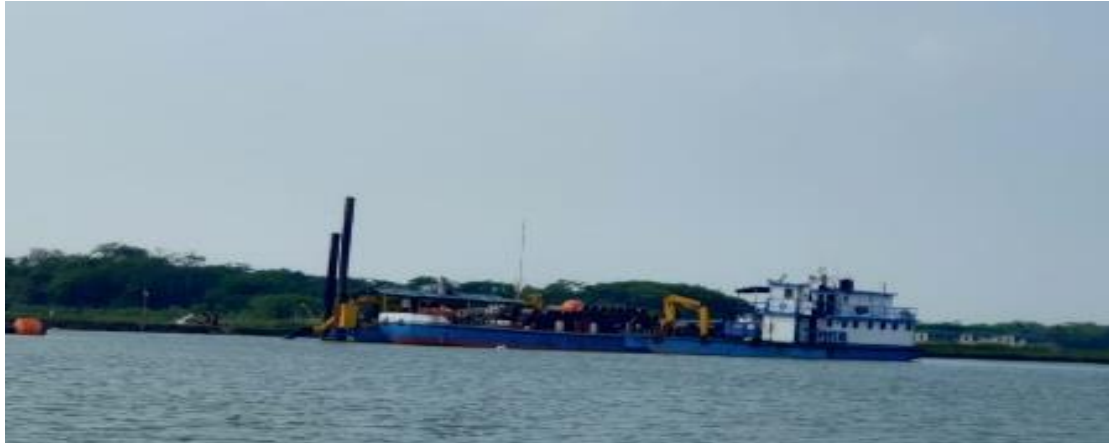
**Figure 13: Suspended dredging work at Laharhat**

The contractor (Lot3) has already finished with dredging operations and post survey works. Completed dredging length 2.1 kilometers, wide 65 meters and Draft 2.8 meters.

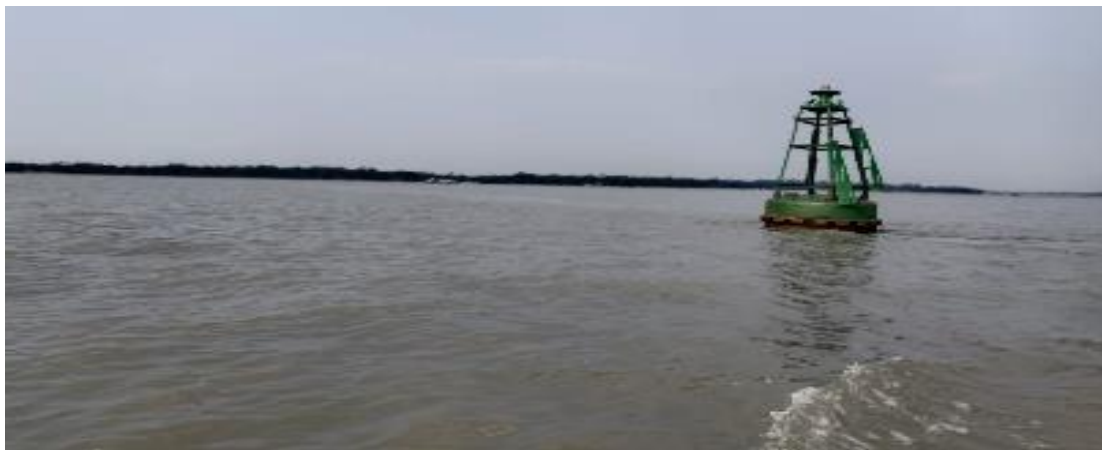
**Figure 14: One green color Buoy at the Laharhat intersection**

Bheduria Launch Ghat. It was noticed that only Laharhat intersection point is marked by one green colored buoy but no buoy was seen at the intersection point at Sreepur.

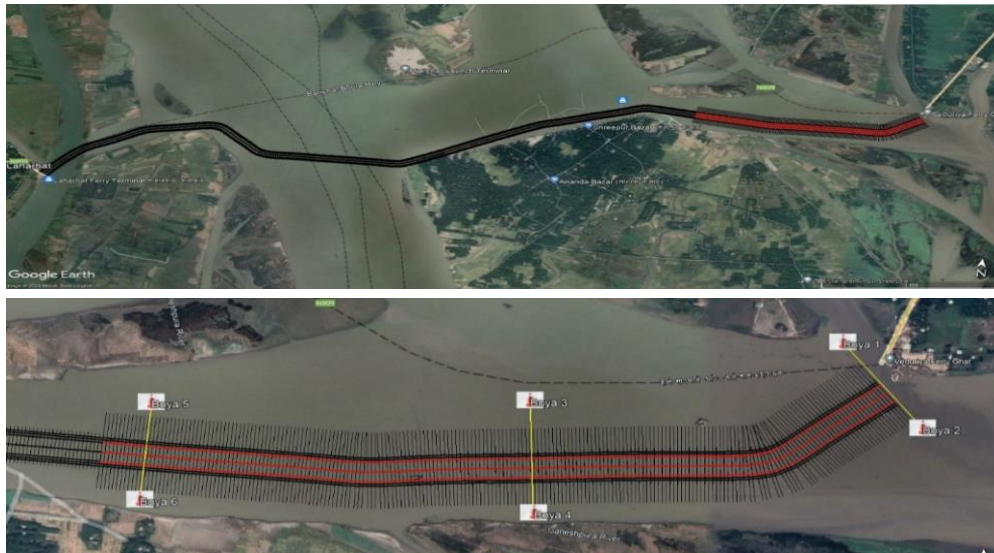
**Figure 15: Buoy Location within the Dredged Section**

To mark the dredging area, special markings are found to be essential to install for safe & trouble-free maneuvering/navigation through Route 21 for ferry ship (Laharhat-Bheduria). As per IALA (International Association of Marine Aids and Lighthouse Authorities) Buoyage system, dredging as above picture mentioned area, the Route 21 to be covered by required yellow buoys with yellow light flashing at night in every km of dredged distance.

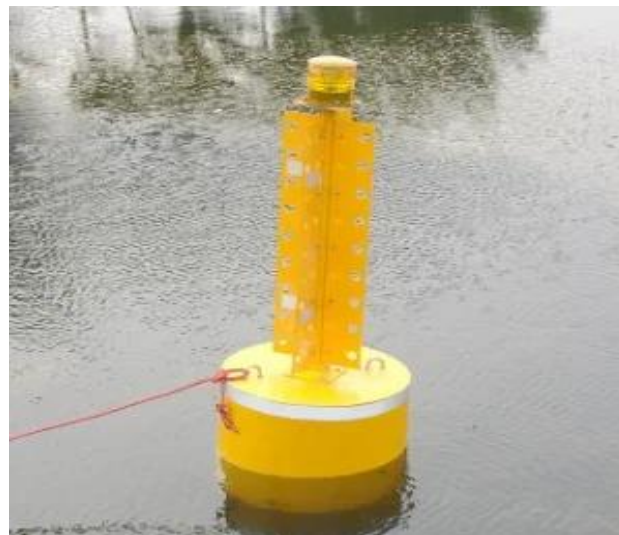
**Figure 16: Yellow Buoy**

Yellow buoys indicate special markings such as traffic separations, dredging areas, fish net area etc. Dredged Route 21 to be installed by adequate buoys as per IALA Buoyage System at the earliest. IALA encourages its members to work together to utilize all the aids to navigation and to ensure the movements of vessels are safe.
