MONTHLY PROGRESS REPORT

APRIL 2023

**Consultancy Services for Supervision & Monitoring of Performance-Based
Dredging Contracts with Maintenance Dredging and Installation & Maintenance
of Navigational Aids along the Navigational Routes under the Contract**

Bangladesh Regional Waterway Transport Project 1 (BRWTP-1)- S1A

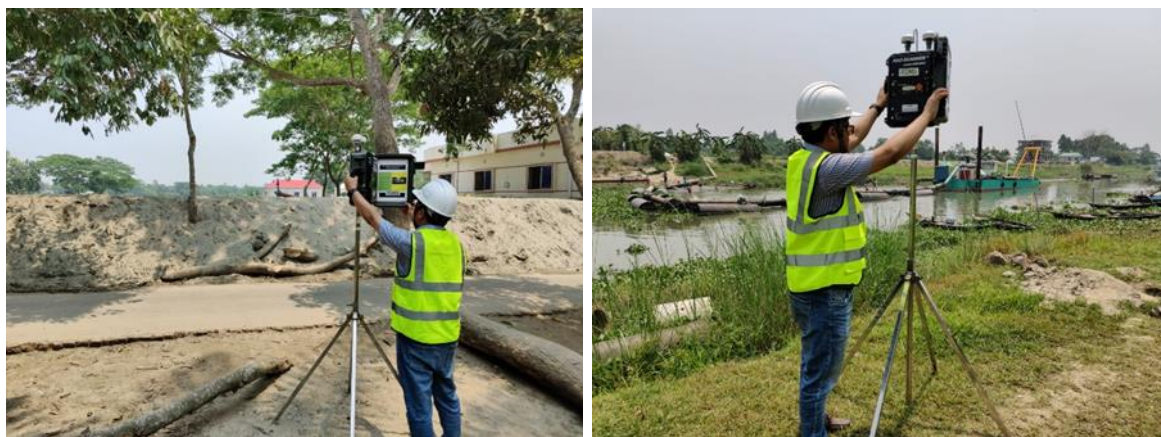
Figure 3: Air quality monitoring for April month at Lot2

The above photographs (Fig3) were taken during air quality monitoring at Solimganj **Error! Reference source not found.**

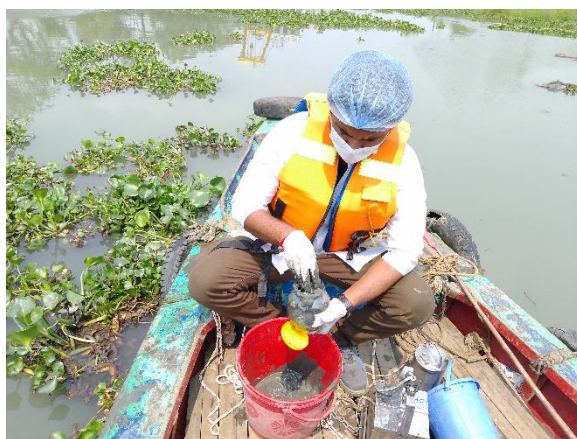
Figure 5: Riverbed sediment sampling at Solimganj ghat

To assess the riverbed sediment quality of the project area, one sediment sample was collected from the dredging sites of Route-9 named Solimganj ghat.

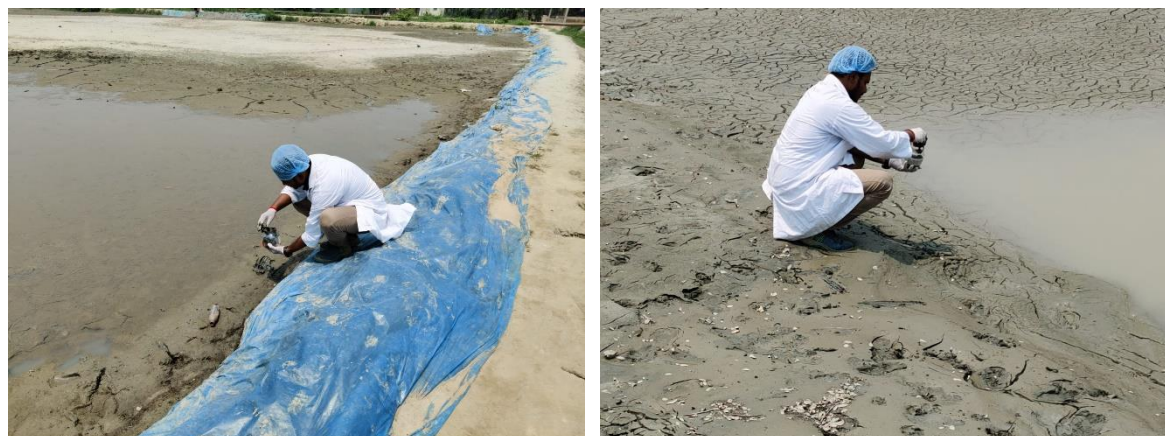
Figure 6: Dredge Material sampling from Dyke no.2 & 5

To assess the dredge material quality of the project area two samples were collected from two dredging disposal site following the USEPA technical manual. Sampling locations has been given in **Error! Reference source not found.**

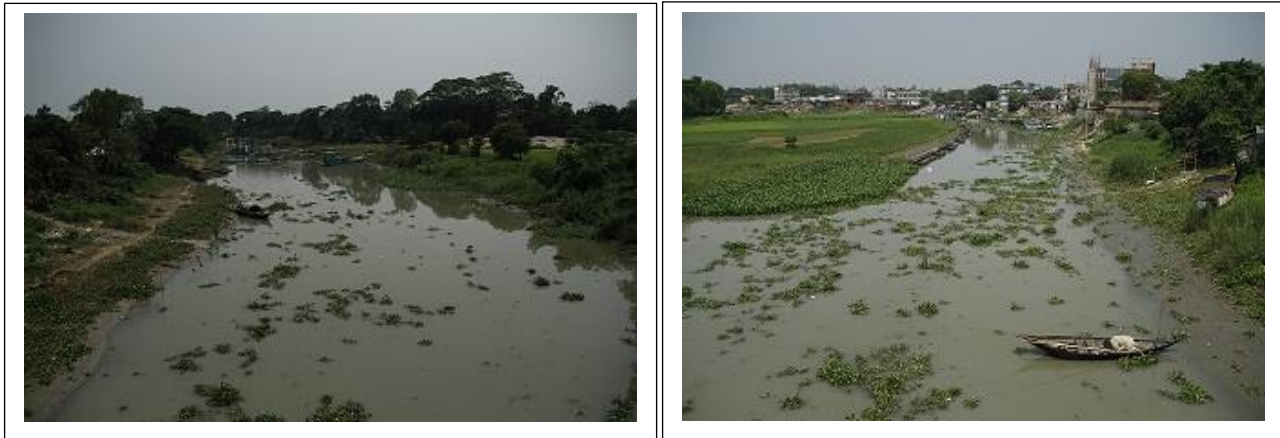
1. Concentration of floating water hyacinths was reduced probably due to either water in-flow or by the movement of the dredger. This allows sunlight to penetrate below the water's surface thus facilitating to enhance primary production of the river.

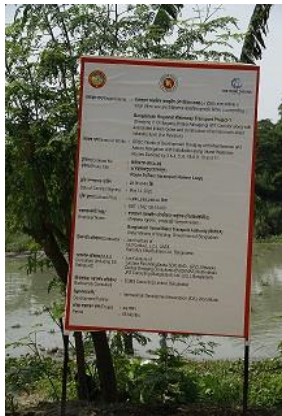
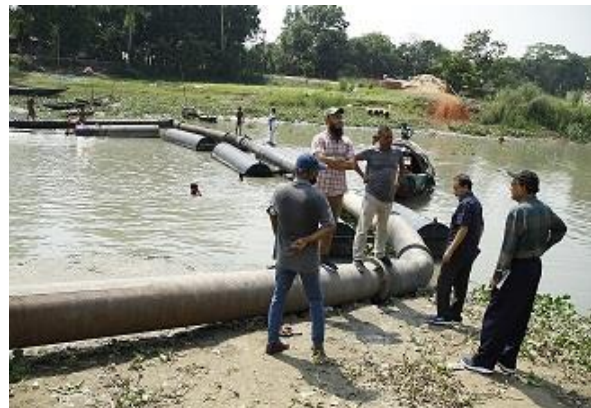
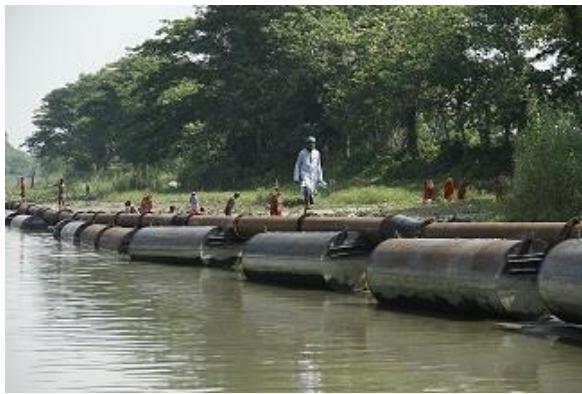
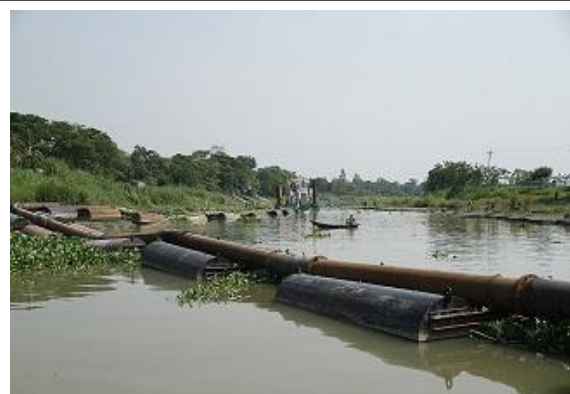
2. Display of information on the project details in English fixed at the site office. However, it is recommended that the information be published in Bangla as well.

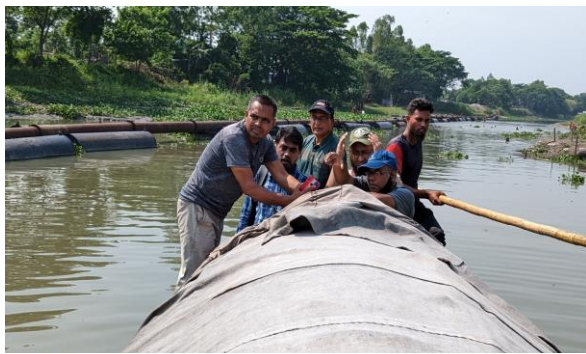
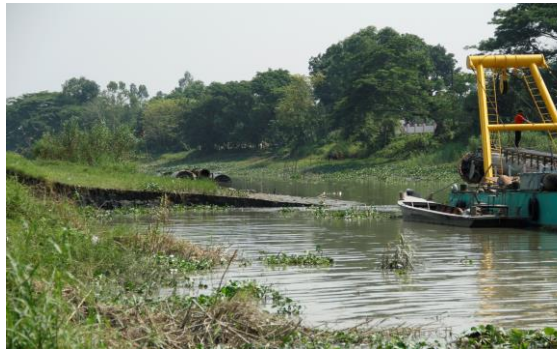
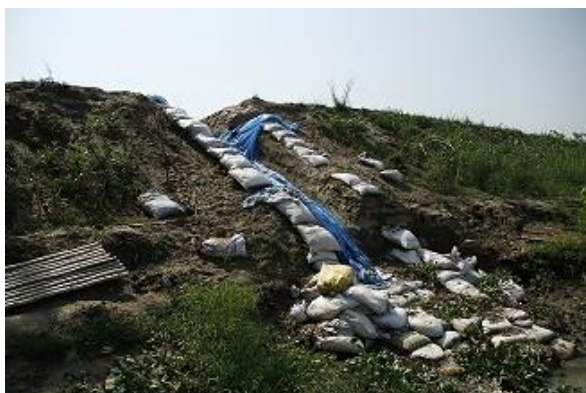
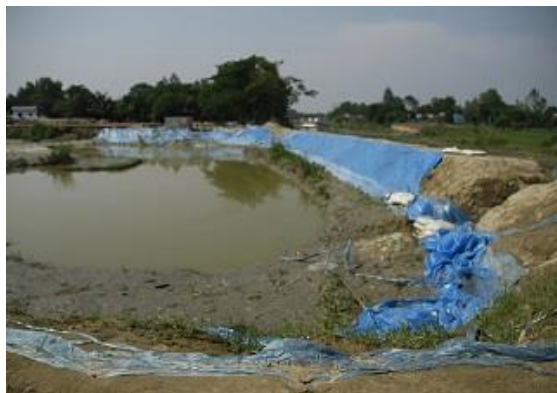
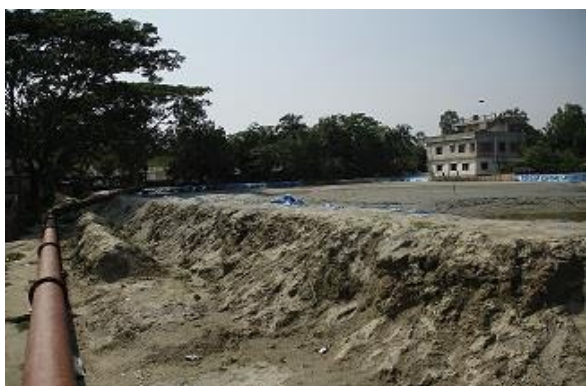
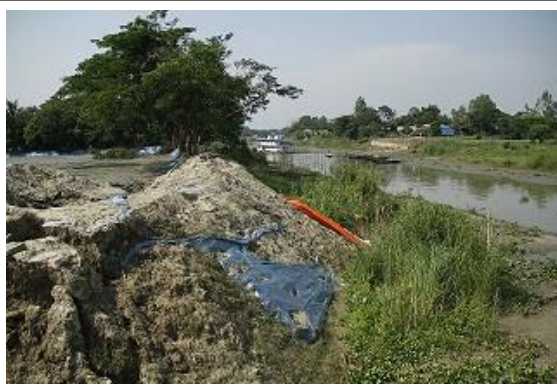
3. The dykes of the dredged material disposal sites are not well protected. Moreover, despite the instruction to use biodegradable materials to strengthen the dykes, it was observed that plastic sheets were used. Recommended to fix the dykes.
4. Detailed site-specific descriptions of the dredged material disposal sites were not provided. Moreover, some trees were removed from the disposal sites. The contractor was informed earlier not to fell/remove any trees which is a violation of the agreement.

Tattered condition of the dredged material disposal sites which is evidence of non-compliance of the Code of Conduct guidelines. Checking of dredging depth with the help of lead, Lot-2, Route-09. (Bancharampur-Homna Loop) Solimganj.

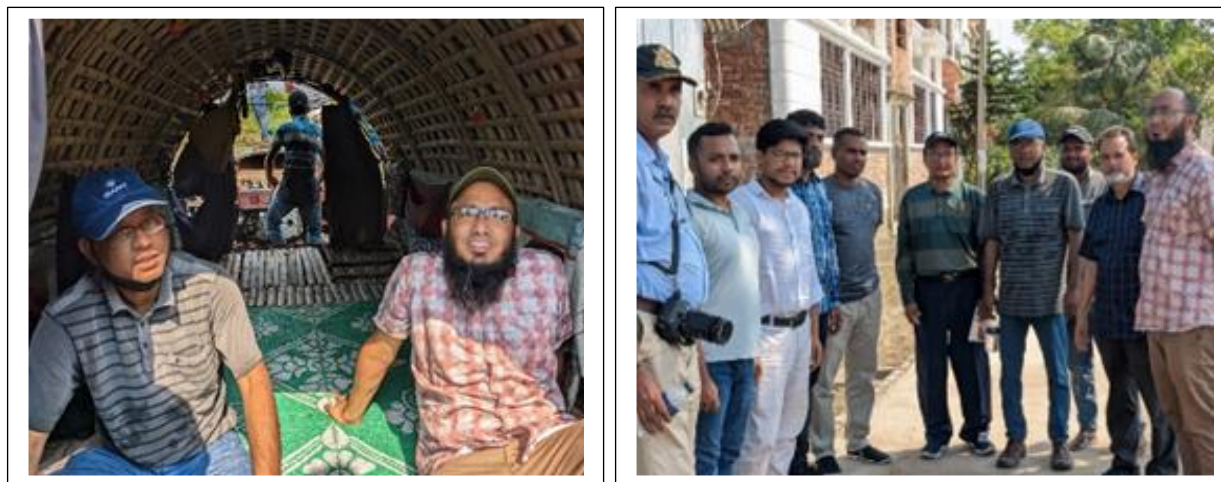
5. The dredging area dredged by dredger Karonfury-07 & Karonfury-03, near Solimganj Bridge has been inspected by the team using an engine-driven boat. The team visited the whole length of the dredging area, the depth of cutting was randomly checked at several sections of the river. After site visit the Team Leader advised the site engineers/representatives to expedite and boost up the dredging works following the rules and regulations.
6. Recommended that the internal monitoring of the dredging, dredged material management and other associated issues by the contractor needs to be boosted, improved, and documented.

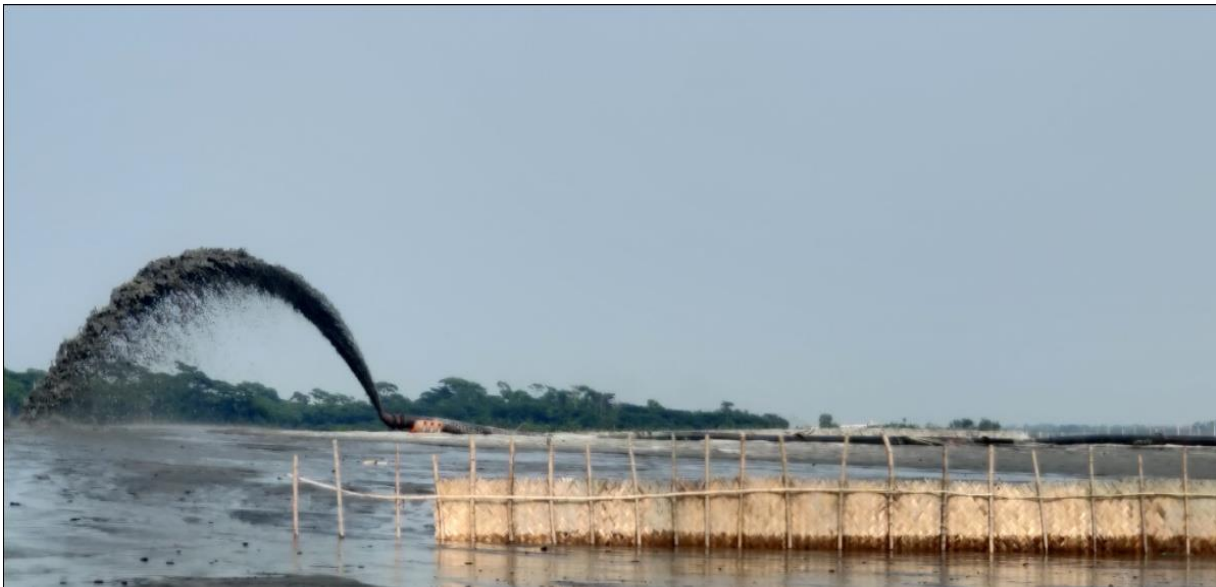
Figure 9: Photo of dredge material disposal area R16-D1

Disposal Area: Disposal area R16-D1 used up-to 30th April 2023.

16-D1: Area is 17,633 sqm, Height is 1.88m (approx.) and estimated capacity containing 33,150 cum spoils.

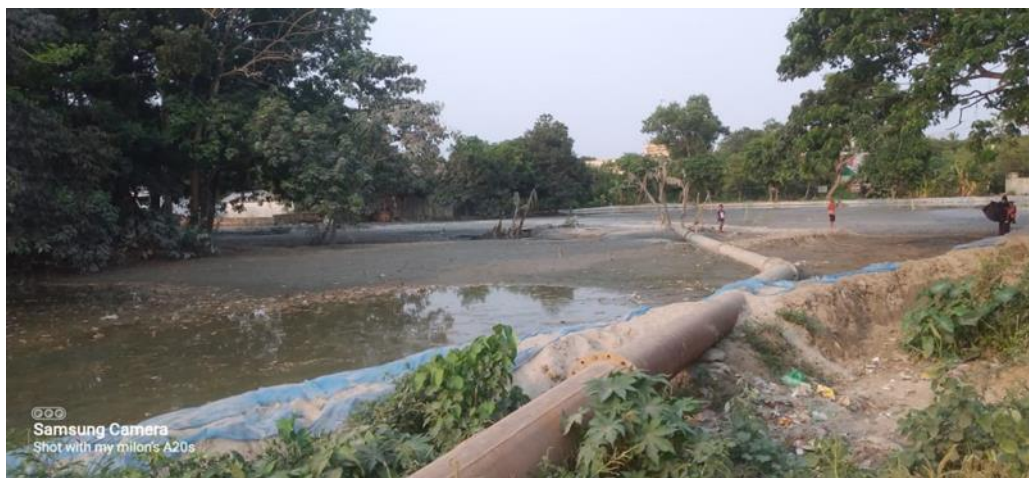
Figure10: Photo of dredge material disposal area R 9-D6

(3) R09-D6: Area is 5707 sqm; Height is 2.5 m and Estimated capacity containing 14,267cum spoils.

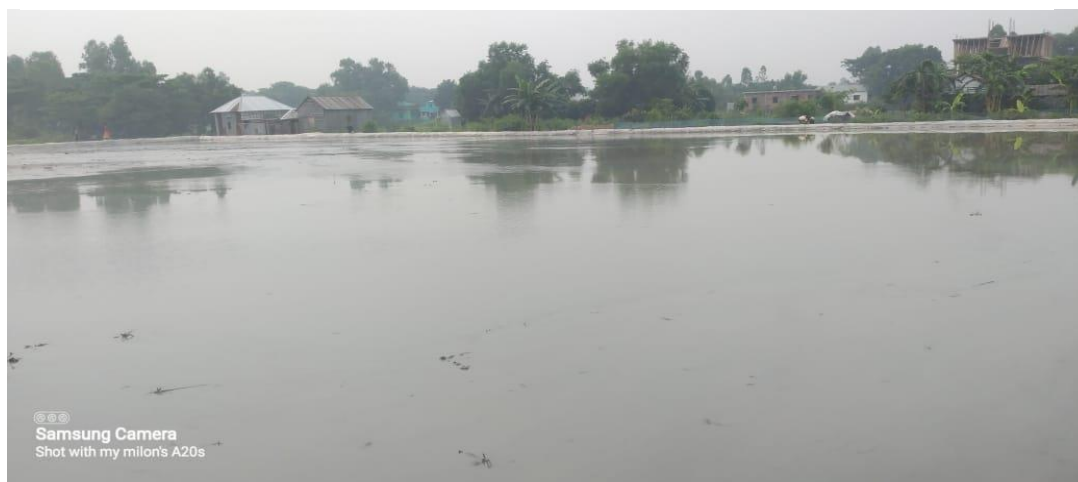
Figure 11: Photo of dredge material disposal area R09-D5

(2) R09-D5: Area is 5,888 sqm, Height is 3.0m and estimated capacity containing 17,664cum spoils.

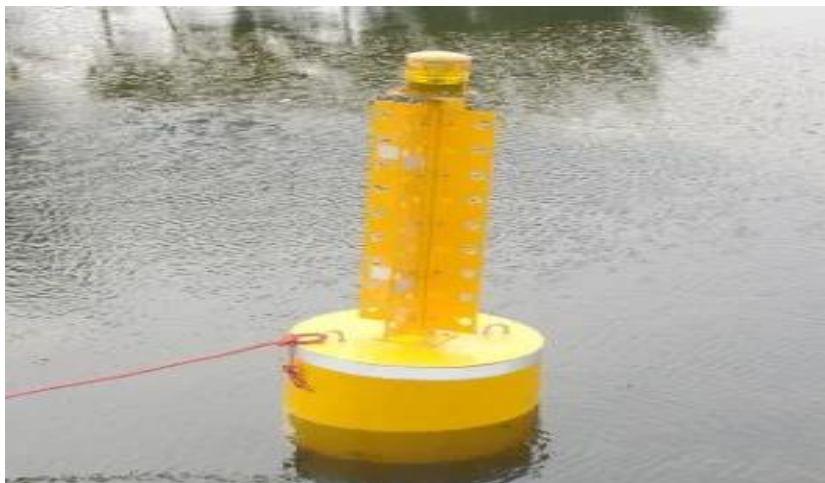
Figure 13: Yellow Buoy

To mark the dredging area, special markings are essential to be installed for safe & trouble-free maneuvering/navigation for ferry ship. As per IALA (International Association of Marine Aids and Lighthouse Authorities) Buoyage system, all the River Route to be covered by required yellow buoys with yellow light flashing at night in every km of dredged distance.

Yellow buoys indicate special markings such as traffic separations, dredging areas, fish net area, etc. IALA encourages its members to work together to utilize all the aids to navigation and to ensure the movements of vessels are safe.
