MONTHLY PROGRESS REPORT

July 2023

Bangladesh Regional Waterway Transport Project 1
BRWTP-S1A

**Consultancy Services for Supervision and Monitoring of Performance-Based
Dredging Contracts with Maintenance Dredging and Installation and Maintenance
of Navigational Aids along the Navigational Routes under the Contract**

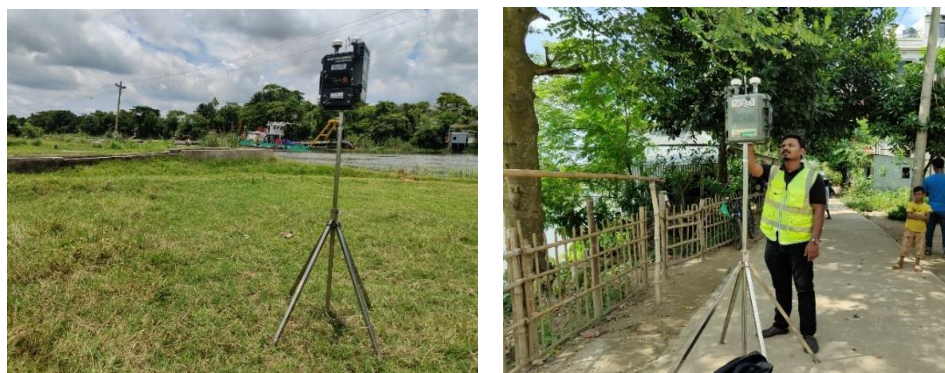
Figure 8: Air Quality Measurement at Route 16 and Route 09

Air quality	In this month, monitoring of four sample points Air quality has been conducted. All the testing parameters were found within the standard limit. Detail has been discussed.	No mitigation measure is required.	Duration of sampling time to be mentioned
Noise level	Monthly monitoring of noise level has been conducted in this reporting month. Results were found within the standard limit. Detail has been discussed.	No mitigation measure is required.	Some erosion of the river bank was observed during S1A Team visit due to dyke failure
Riverbank Erosion	During the reporting month, no issues were observed regarding riverbank erosion or flooding.	No mitigation measure is required.	Setback distance along the river banks and dykes to be maintained and monitored
Drainage congestion	The dredging work in July 2023 is being carried out in Salimganj Ghat (Route-9) area. During site observation, the outline for water passing from the dredge material was found to be functional.	No mitigation measure is required.	To be checked at regular intervals

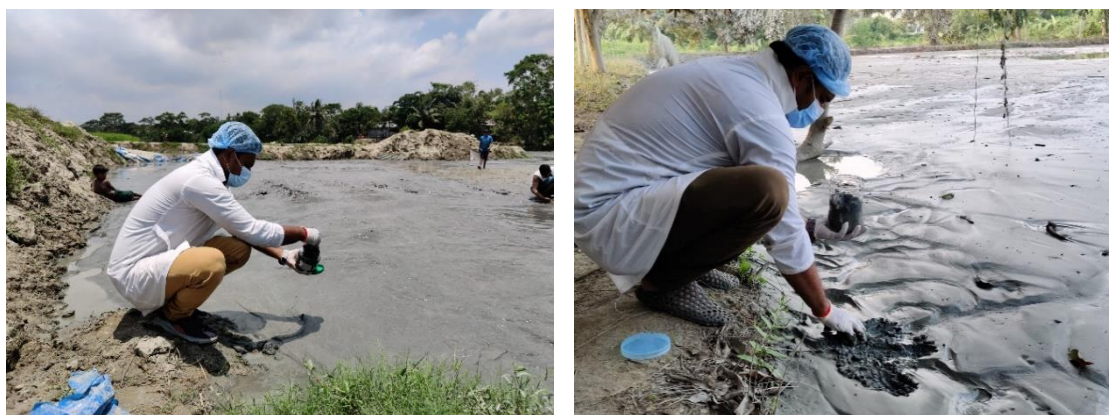
Figure 9: River Bed and Dredge Material Sampling at Lot3 and Lot2 Sites Respectively

Using the various pollution indicators, it was found that the river bed sediment is less contaminated by toxic metals during the study but the sediment quality may degrade in the near future due to increasing

The observed concentrations of Zinc (Zn) for both Lot 2 and Lot 3 though within the limits but is of concern. The extent of Zn adsorption increases with an increase of pH. Furthermore, the adsorption of zinc increases with increasing particle size. The important geochemical phases, iron and manganese oxide also act as the active support material for the adsorption of zinc ions. Zn occurs naturally but the concentration increases from several sources like agricultural runoffs, wastes, industrial effluents, etc. At acute concentrations it probably kills fish by destroying gill tissues. The action of zinc undoubtedly differs at different concentrations, it varies with life history, and needs to be monitored.

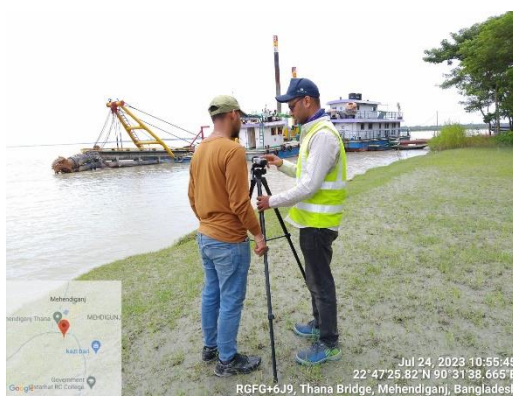
Figure 10: Noise monitoring near Solimganj Ghat near River Route 09

15.	4-10	Date time missing in the photo	Updated as instructed.	
16.	4-11	exceeds the approved limit	The maximum recorded value, referred to as Lmax, was observed. The Leqday value, which was 60.32, falls within the standard acceptable range.

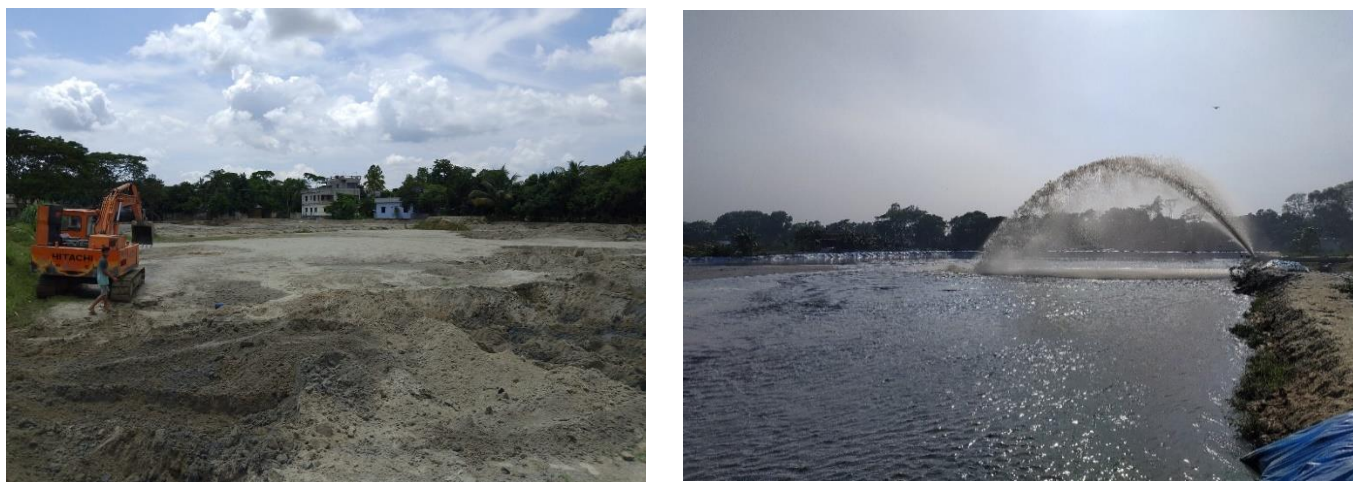
Figure 13: Photo of dredge material disposal area R09-D7 and R16-D2

Because of the monsoon season, there was no dredging activity observed during the monthly site visit in July 2023. Two dredgers were placed in Route 16 (Opposite side of Patarhat Launch Terminal) and the other one was in Route 21 (near Bheduria Ferry Ghat). No new dikes were constructed for dredged material disposal during this reporting month.
