# MONTHLY PROGRESS REPORT

August 2023

**Consultancy Services for Supervision and Monitoring of Performance-Based  
Dredging Contracts with Maintenance Dredging and Installation and Maintenance  
of Navigational Aids along the Navigational Routes under the Contract**

**Bangladesh Regional Waterway Transport Project 1  
BRWTP-S1A**

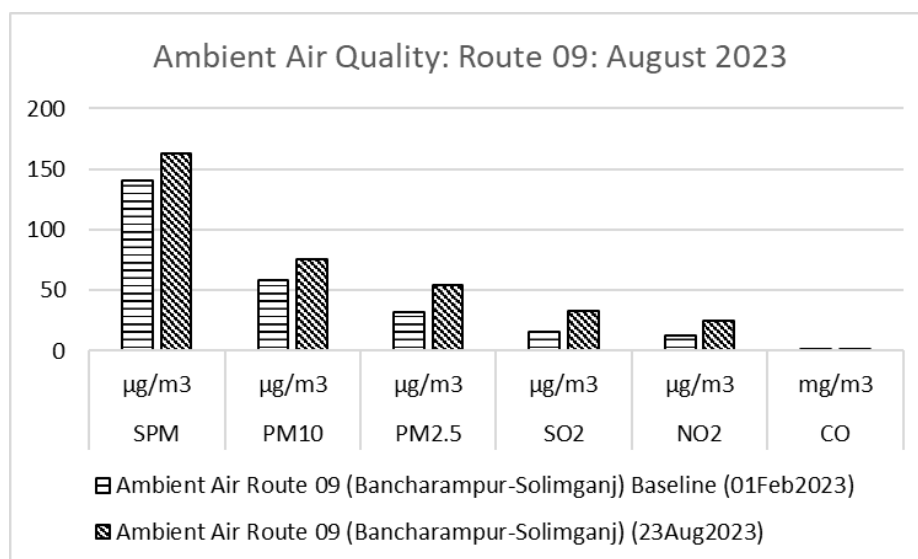
**Figure 1: Ambient air quality of Route 09, Lot 2: comparison of August 2023 data with the baseline.**

As seen from the graph above (Fig. 1) that the August values fall within the ECR 2023 approved ranges for all the air quality parameters (SPM, PM10, PM2.5, SO2, NO2), but are higher than the baseline indicating that there have been some changes in the ambient environment of the dredging sites. However, in this respect dredging may not be the lone factor as the area is near the growth center and human habitation with busy traffic and dusty herring-bone/kutchra roads, which may also have a bearing on the air quality results.

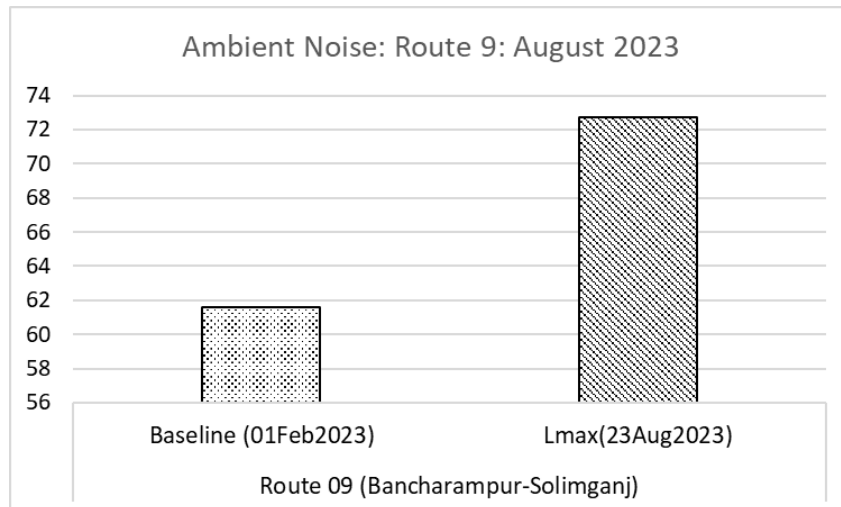
**Figure 2: Assessment of Noise Level Measurement**

The results of the noise level monitoring indicate that the noise levels at the monitoring locations are in compliance with the International Finance Corporation's Environmental, Health, and Safety guidelines. However, it is noted that the level was within the standards set by Bangladesh. The maximum noise level (Lmax) at Route 9 was significantly high than the baseline value. This may be due to the fact that when the baseline data was collected in February the dredgers were not operating while in August the dredgers were active.

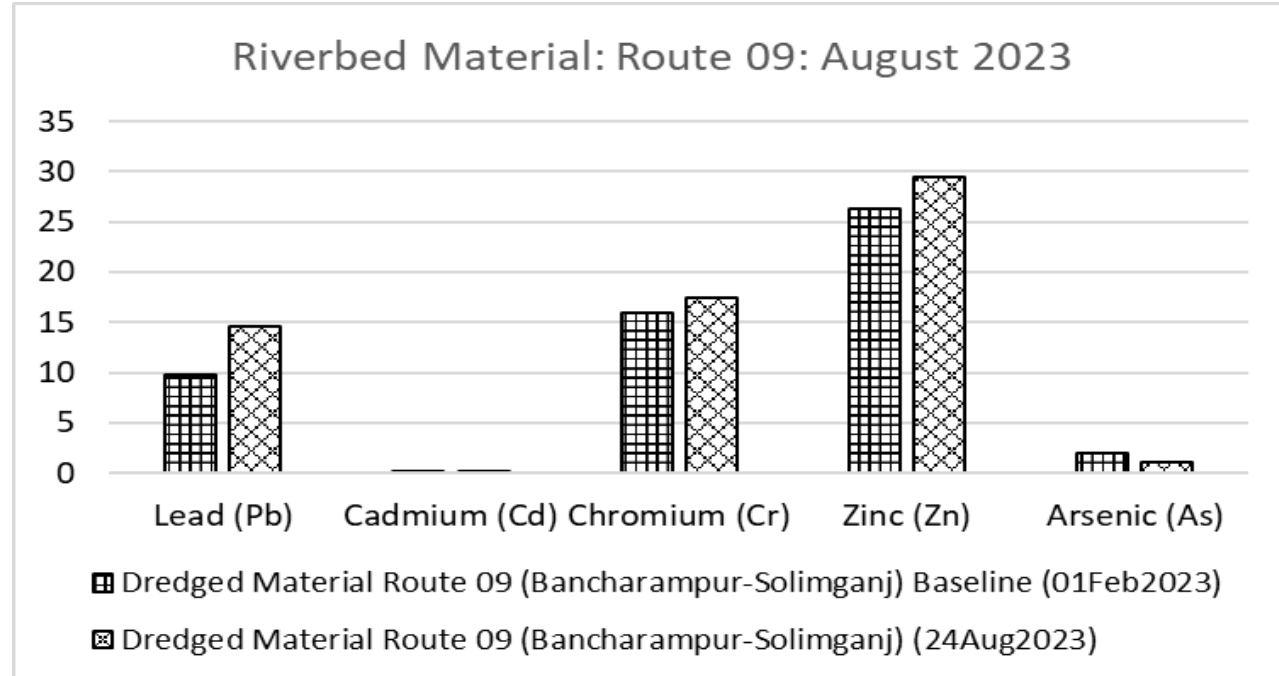
**Figure 4: Riverbed Material Assessment of Route 9**

This monthly report focuses on determining the levels of various contaminants in dredged material. Lead, an element with a concentration ranging from 14.59 to 19.33 mg/kg, was found in the samples. Cadmium, another contaminant, was detected within the range at 0.05 to 0.07 mg/kg. The presence of chromium, zinc, and arsenic were also identified. Chromium concentrations varied from 17.4 to 20.2 mg/kg, while zinc content ranged from 25.62 to 29.42 mg/kg. Arsenic, on the other hand, was found at levels of 0.98 to 1.2 mg/kg in the samples. These results indicate the composition of the dredge material and provide valuable information regarding the presence of these specific contaminants.

There are no approved levels for the heavy metals mentioned in the ECR 2023. However, the mere presence of these heavy metals indicates some toxic effects on the environment, and in particular the human beings using the aquatic resources. The area being in the vicinity of the growth center and human

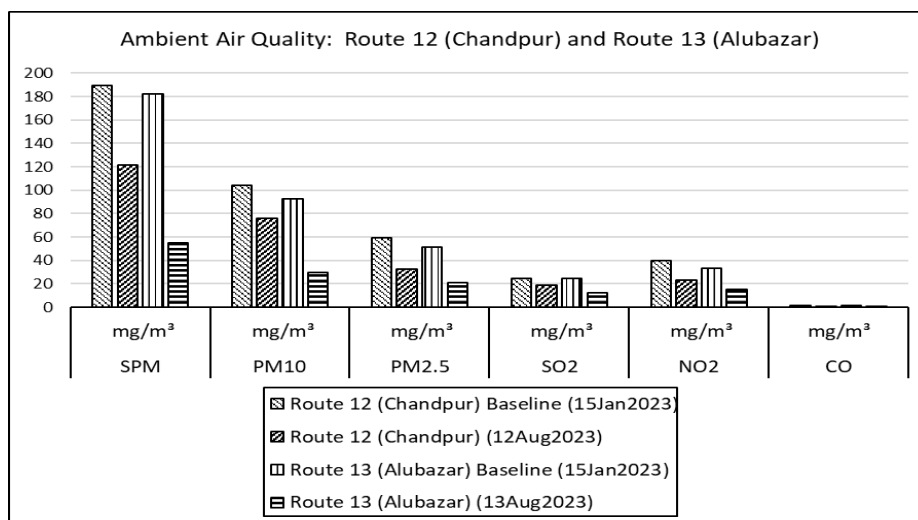
The results show that the concentration of PM10, PM2.5 and SPM were found within the standard limits in all locations. Also, the concentration of gaseous substances like CO, NO2, and SO2 are found below-standard in all monitoring locations.

For Lot 3 ambient air quality was measured during the month of August 2023 for Routes 12 and 13 and compared with the baseline data respectively (Fig. 6). The results complied with the ECR 2023 approved values. Values of all the parameters for both the routes were lower than the baseline values. The reason may be due to the frequent spells of precipitation close to the dates of sampling when the air quality improved because of the natural process.

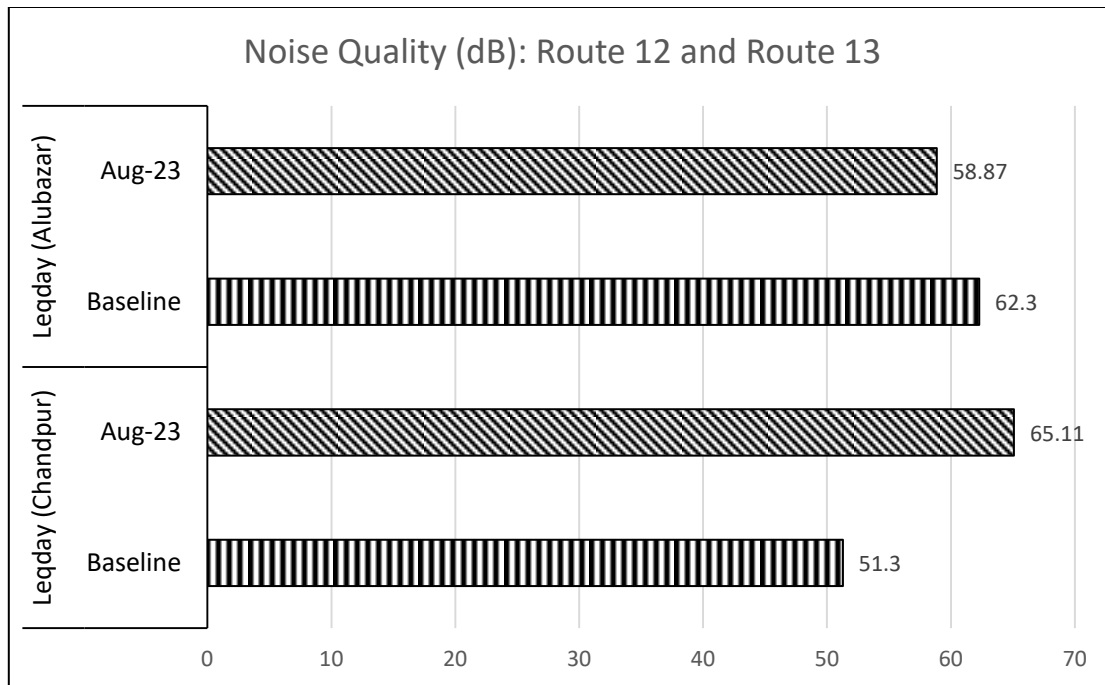
**Figure 6: Noise monitoring in Chandpur Boro station (R-12)**

Comparison of August 2023 ambient noise levels (Fig. 08). at Lot 2 and Lot 3 sites with the baseline data. In Route 12 (Chandpur), the site is quite busy with the hustle and bustle of the ferry ghat as a result the noise level was higher (dB 65.11) than the baseline (dB51.3). While Route 13 (Alubazar) is comparatively less busy than Route 12. Correspondingly the noise level at Route 13 (dB 58.87) was lower than the baseline data (dB 67.3). All the measurements were within the ECR2023 approved limits

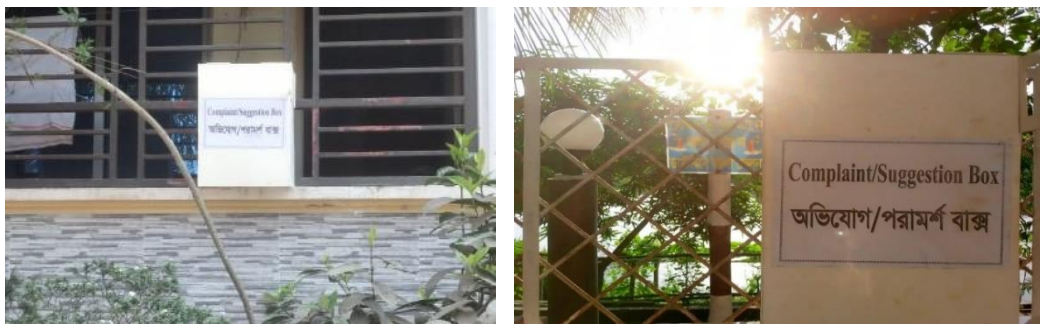
Local community people, labors and other stakeholders have a ground to report their concern, grievance, and suggestion to the contractors by submitting their grievance through the proposed mechanism. The monitoring team found that grievance mechanism is being followed during the dredging activities.

**Figure 20: Grievance Box at Dredging Sites of Lot2**

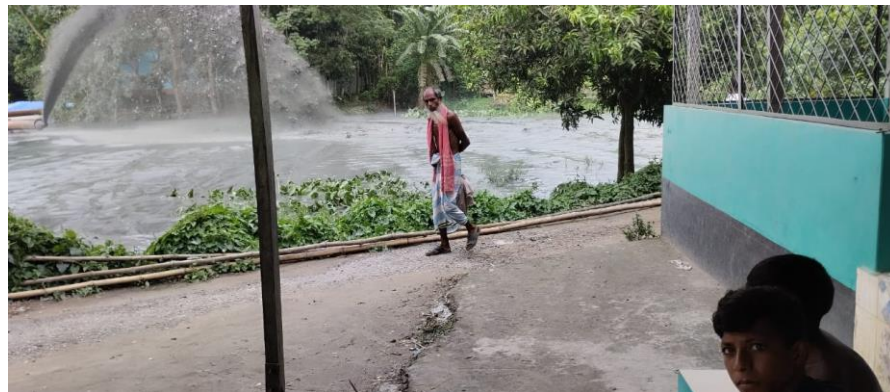
**Figure 22: Photo of dredge material disposal area R09-D15**

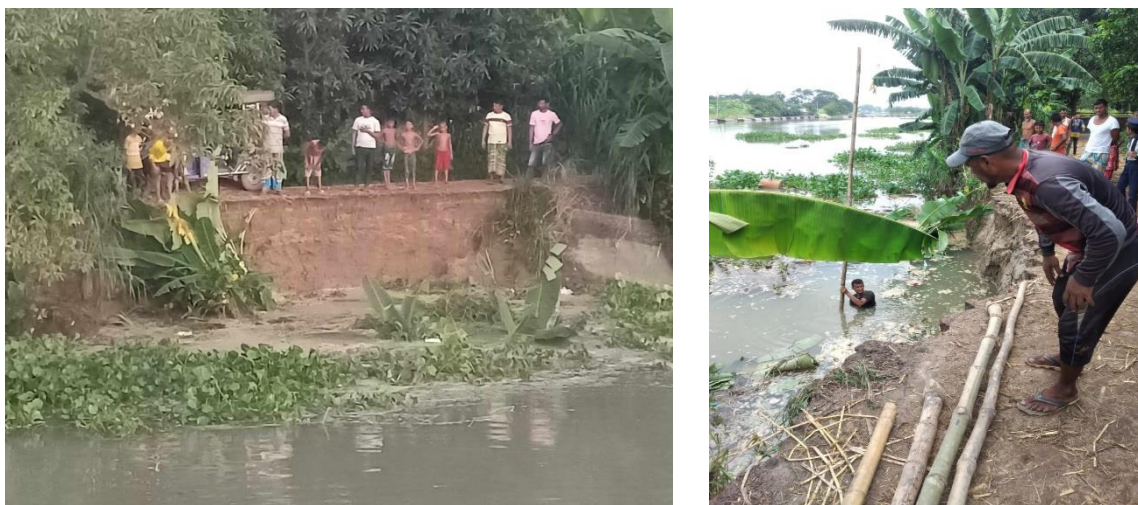
Date	Activity	Relevant Route/Contractor/Consultant
20 August 2023	Riverbank along with the adjacent road eroded at Nilukhi, chainage of Route 9. Some tension among the local people. Protection of the riverbank initiated.	Lot 2 Route 09
	Monitoring survey along Route 21; Laharhat - Bheduria	Lot 3, Route 21
21 August 2023	Repair work of the road and riverbank protection	Lot 2, Route 09
	Finished monitoring survey	Route 21, Lot 3
22 August 2023	Monitoring survey at Route 16; Laharhat to Patarhat	Route 16, Lot 3
23 August 2023	Monitoring data processing	Route 16, Lot 3
23 August 2023	Coordination meeting between client and S1A regarding GRM issues	PIU, S1A
	Consultation with the local people, stakeholders	Lot 2
	Monitoring data processing, Route 21	Lot 3
	Sampling and environmental data collection, Route 9 Titas River	Lot 2
26 August 2023	Sound velocity profile checking at Sreepur	Lot 3, Route 21
	Monitoring survey ongoing by single beam	Lot 3, Route 16

**Figure 23: Road Sliding and Road Repairing of Nilukhi**

27 August 2023	Ongoing monitoring work, checking gauge connections by leveling.	Lot 3, Route 16
28 August 2023	Ongoing survey at Route 16, checking BM at Patarhat with BIWTA team	Route 16, Lot 3
29 August 2023	Consultation with the local people (Land Owner) at Solimganj Bazaar	Route 09, Lot 2
30 August 2023	Repair work of the road and riverbank protection at Nilukhi Route 9	Lot 2
