# MONTHLY PROGRESS REPORT

## OCTOBER 2023

**Consultancy Services for Supervision and Monitoring of Performance-Based  
Dredging Contracts with Maintenance Dredging and Installation and Maintenance  
of Navigational Aids along the Navigational Routes under the Contract**

**Bangladesh Regional Waterway Transport Project 1  
BRWTP-S1A**

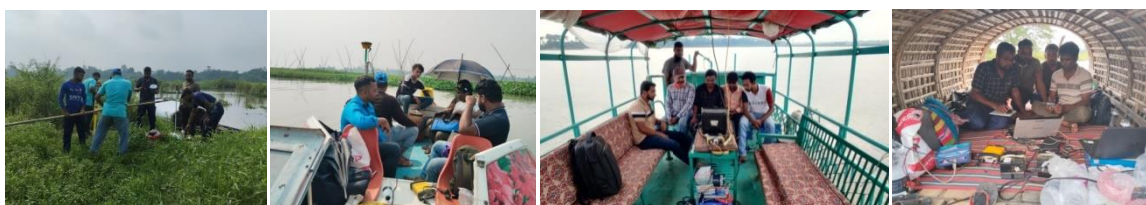
Figure 8: RTK base installed from Bancharampur-Homna loop, route-09, Lot-2; pre-work survey by single beam from Bancharampur-Homna loop, route-09, Lot-2; Hydrographic pre-Survey work is on progress from At hazar-alubazar, Route 13, Lot-3; pre-work survey by single beam from Narsingdhi Northern and Southern Approaches, route- 7&8, Lot-2 (From Left to Right).

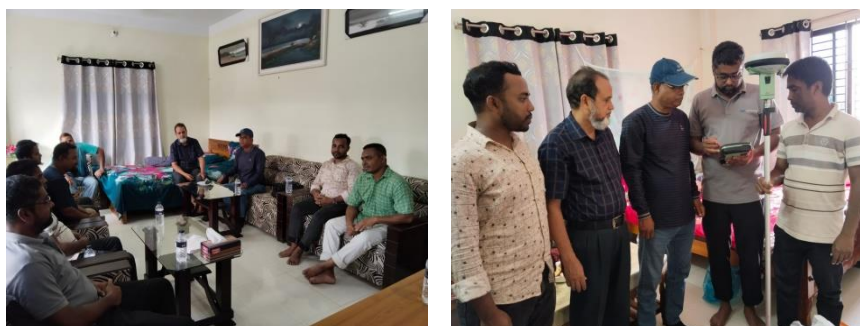
Figure 9: Solimganj site visit with-BIWTA survey team, JPZ consultant and Karnafuly- Gulf Cobla (Lot-2) contractor's representatives at Route- 09 on 07 October, 2023.
