# MONTHLY PROGRESS REPORT

## JANUARY 2024

**Consultancy Services for Supervision and Monitoring of Performance-Based  
Dredging Contracts with Maintenance Dredging and Installation and Maintenance  
of Navigational Aids along the Navigational Routes under the Contract**

**Bangladesh Regional Waterway Transport Project-1  
BRWTP-S1A**

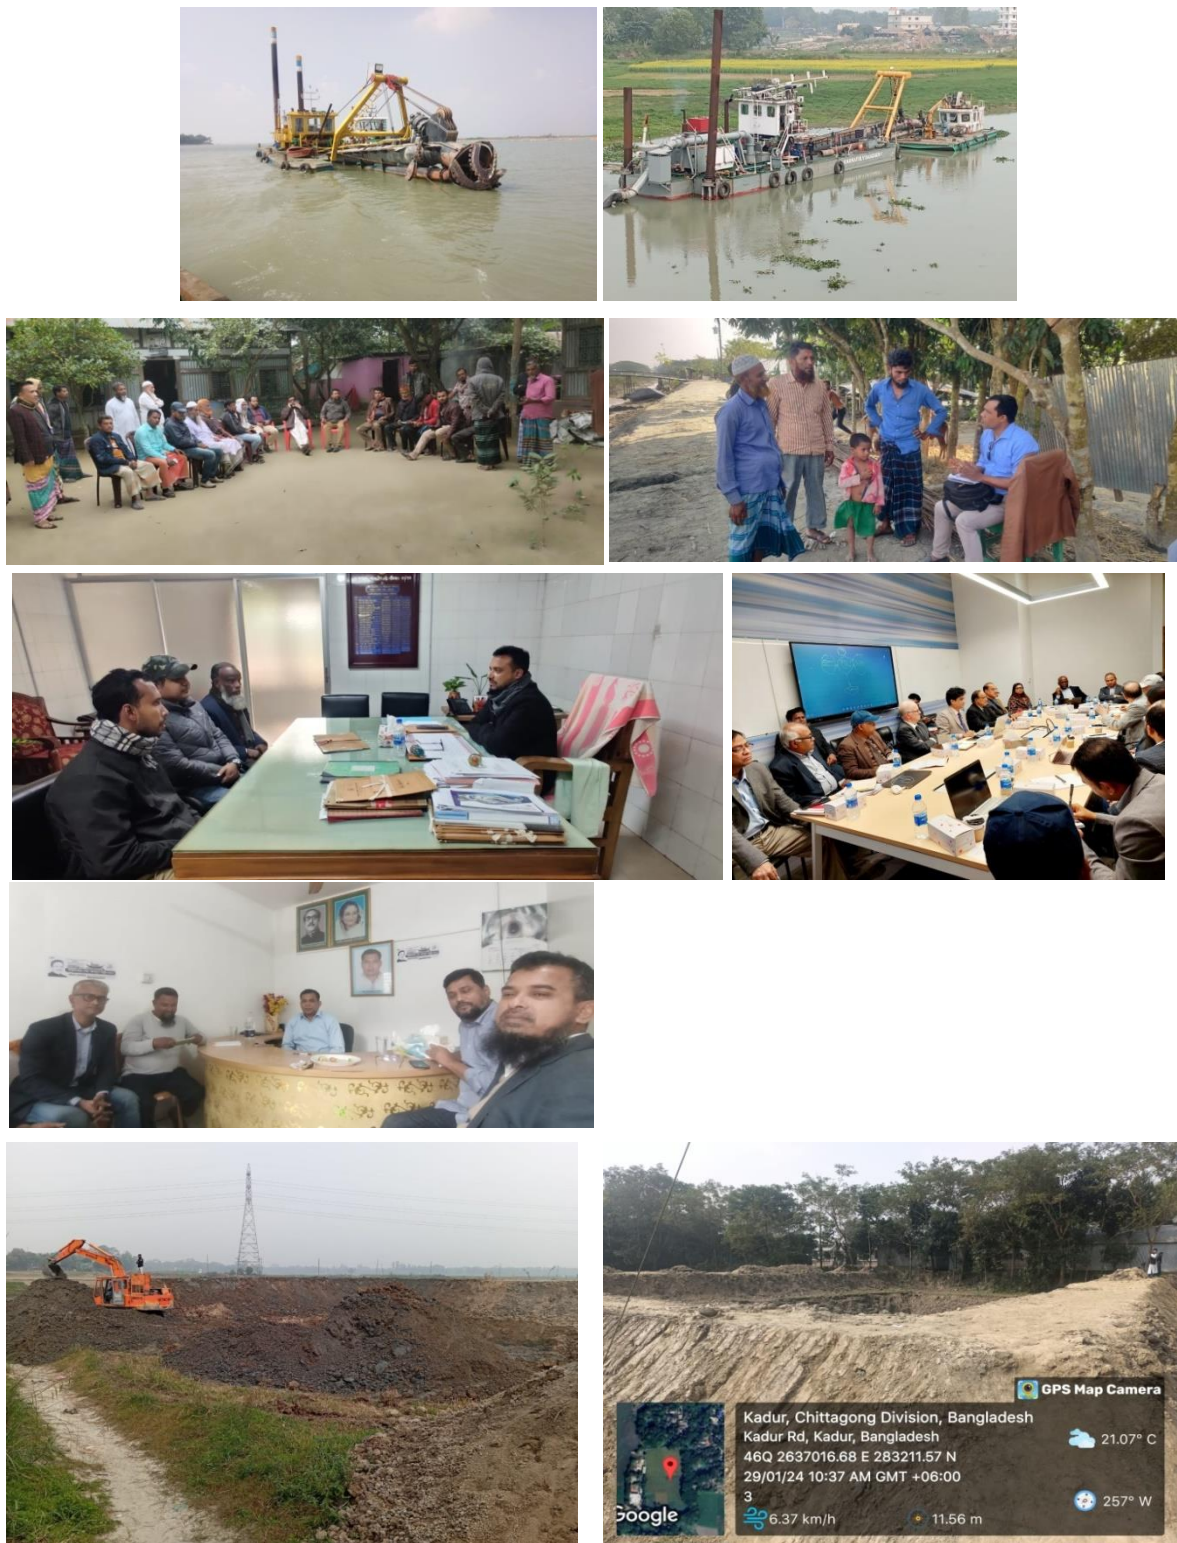
**Figure 10: Photos of Dredger Placement, Meetings with Local Communities, LG representatives, PIU, WB and Dyke Preparation of Lot-2 & Lot-3 site**

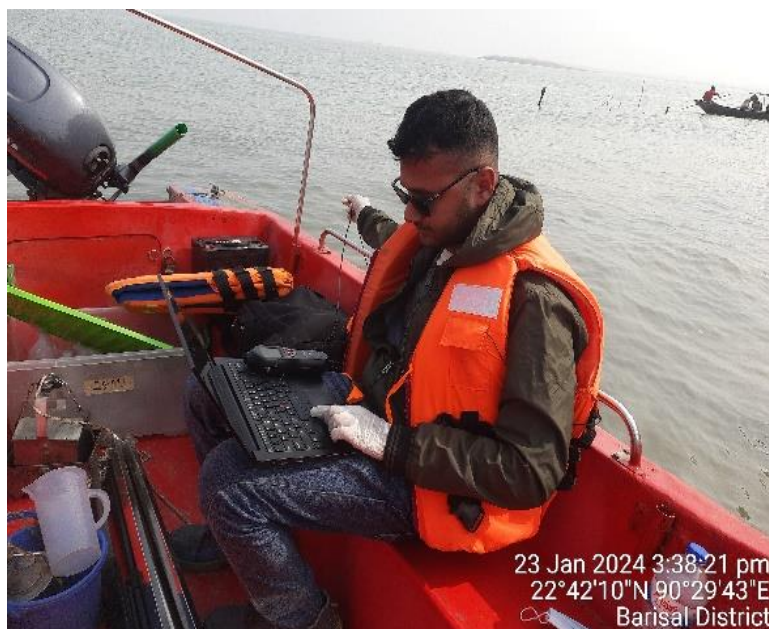
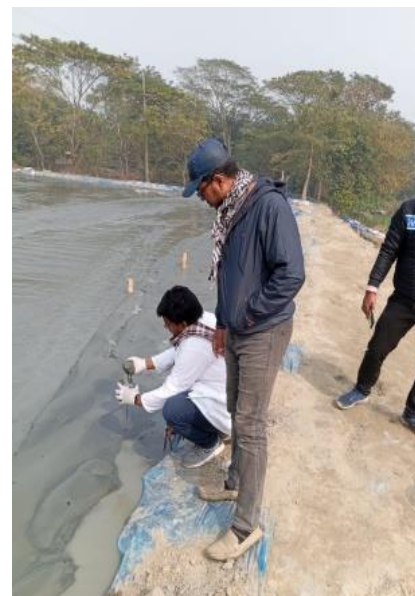
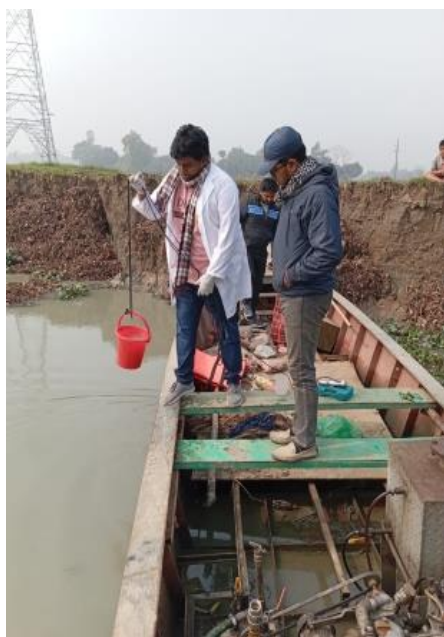
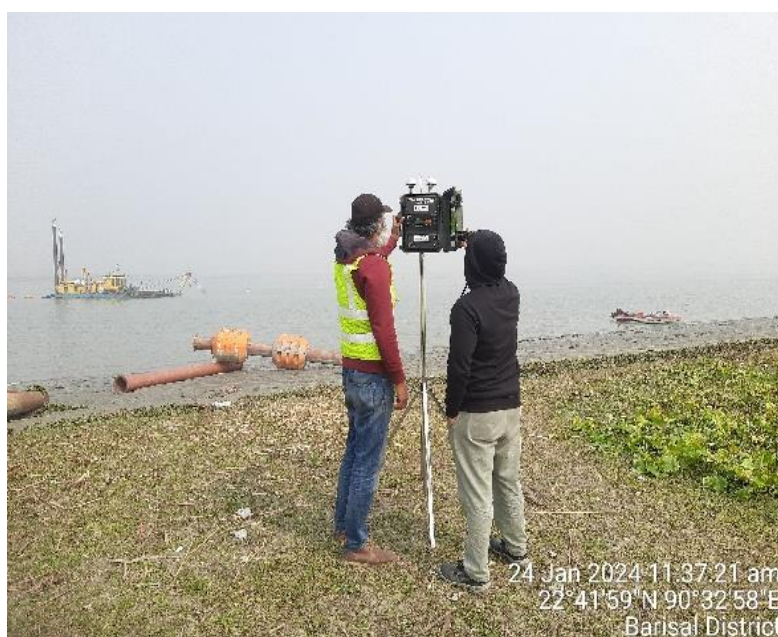
**Figure 11: Photos of Sample Collection for environmental quality assessment in Lot-2 & Lot-3 Sites**
