Consultancy Services for Supervision and Monitoring of Performance-Based Dredging Contracts with Maintenance Dredging and Installation and Maintenance of Navigational Aids along the Navigational Routes under the Contract

Bangladesh Regional Waterway Transport Project-1
BRWTP-S1A

MONTHLY PROGRESS REPORT JUNE 2024

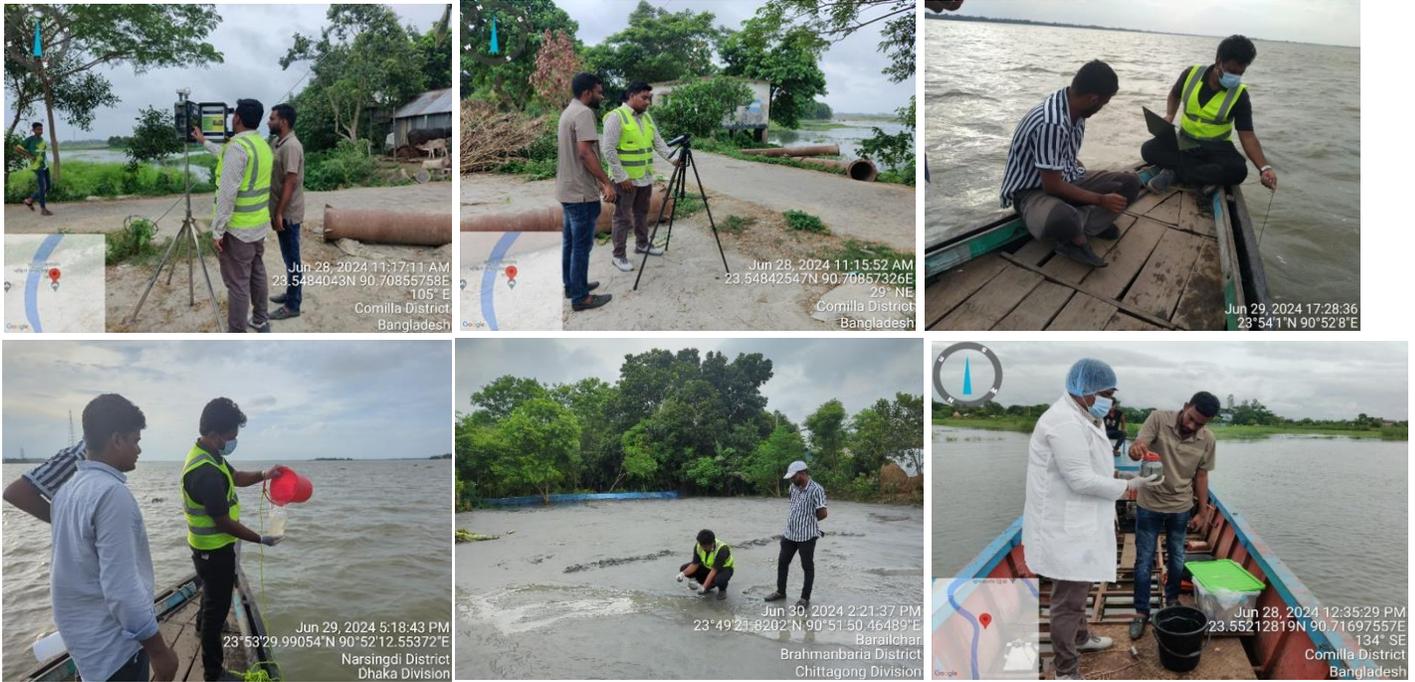
Monthly Environmental Sample Collection at Lot-2 sites:

In June 2024, environmental monitoring was conducted at Lot-2 sites, including Hasnabad Daudkandi (Route-11), Char Modhua, Nabinagar Loop (Route-6), and Salimganj, Bancharampur/Homna Loop (Route-9). No significant air pollution or ambient noise issues were found during dredging. Observations included 25 fish species and 4 crustacean species, with no fish mortality detected. One Ganges River Dolphin was spotted near Char Modhua during monitoring. No freshwater turtles were observed, and locals confirmed their absence in recent months. No significant negative environmental impacts on air, noise, water quality, or occupational health and safety were detected during June 2024.

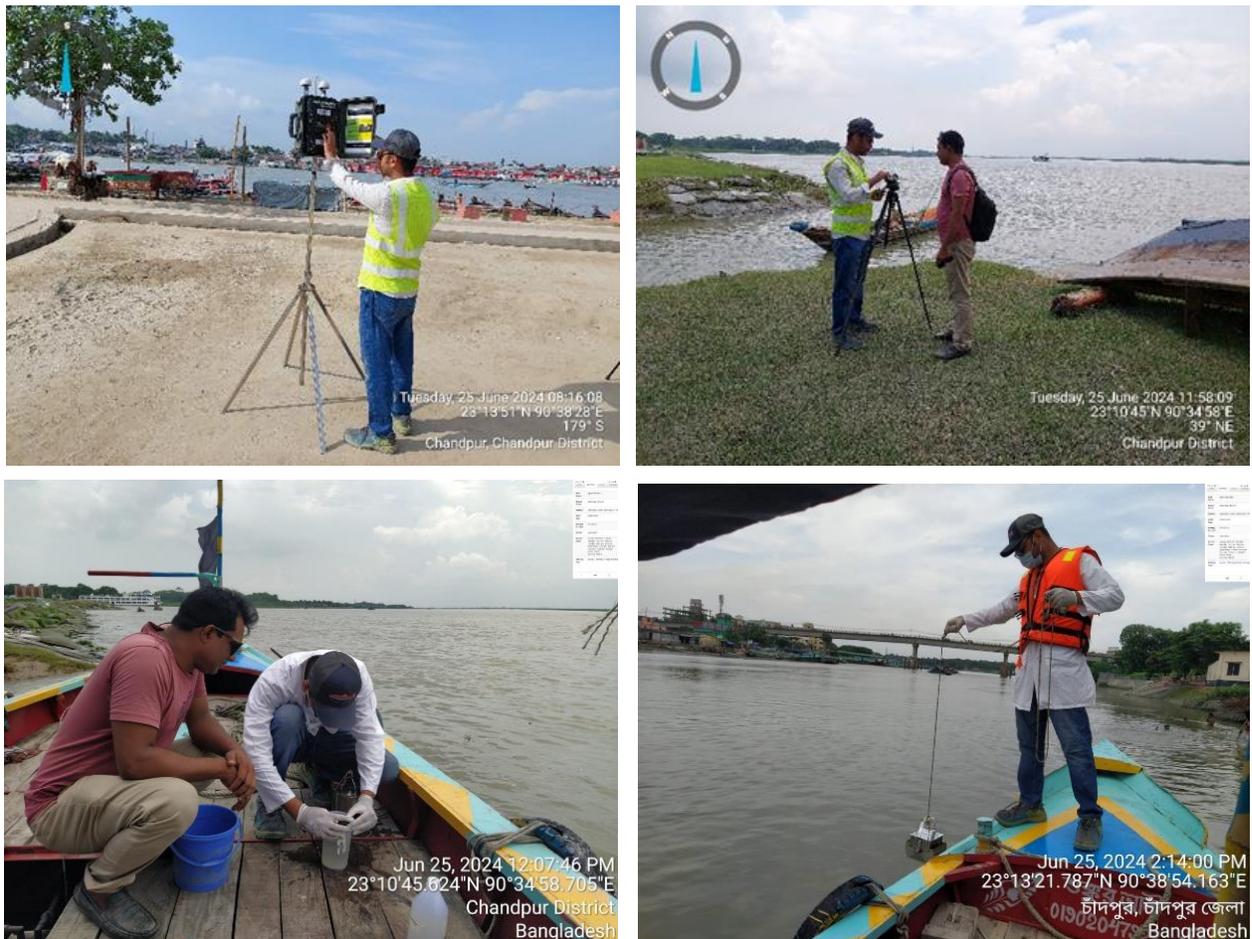
Monthly Environmental Sample Collection at Lot-3 sites:

For Lot-3, environmental monitoring in June 2024 was conducted at Routes 12 and 13 (Chandpur Boro station, Alu Bazar), with samples collected at two locations. No dredging activity or dredgers were present on Routes 12, 13, and 13a, and no new dikes were constructed during this period. Noise levels complied with IFC guidelines (2007), with the highest recorded at 71.09 dBA (Chandpur Boro station) and the lowest at 59.24 dBA (Alu Bazar). Observations included 27 fish species and 6 crustacean species, with no fish mortality detected. No Ganges River Dolphins or freshwater turtles were observed, and locals confirmed their absence. There were no significant impacts on ambient air quality, noise levels, water quality, sediment, or health and safety factors from the project during June 2024.
