Bangladesh Inland Water Transport Authority
(BIWTA)

MONTHLY PROGRESS REPORT AUGUST 2024

**Consultancy Services for Supervision and Monitoring of Performance-Based
Dredging Contracts with Maintenance Dredging and Installation and Maintenance of
Navigational Aids along the Navigational Routes under the Contract**

**Bangladesh Regional Waterway Transport Project-1
BRWTP-S1A**

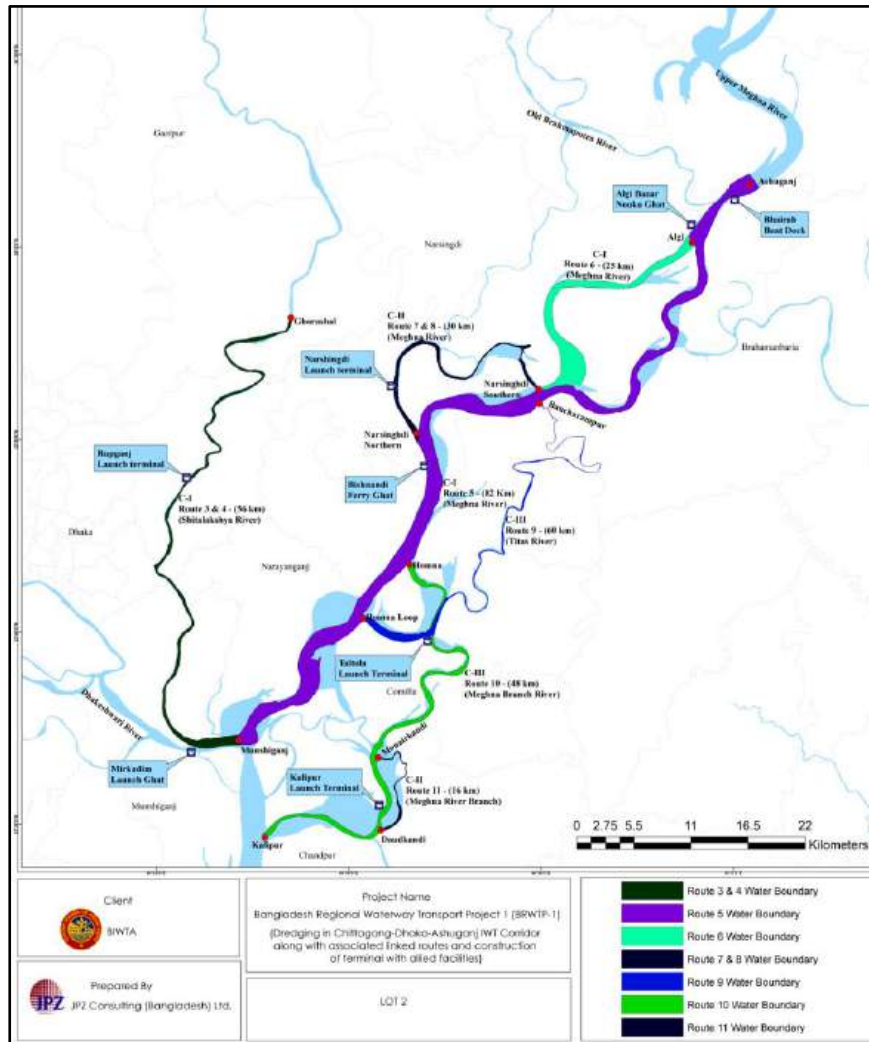
LOT-2

Class	Route No	River/location	Length (Km)	Average width (m)	Shoal Length (km)
I	3 & 4	Shitalakshya (From Ghorashal to Munshiganj)	56	400	-
I	5	Meghna (From Ashuganj to Munshiganj)	82	1200	-
I	6	Meghna (Nabinagar Loop joining Route-5)	25	850	1.5
II	7 & 8	Meghna (Narsingdi Northern & Southern approaches)	30	450	5.8
III	9	Meghna (Bancharampur - Hona Loop)	60	180	19.5
III	10	Meghna (Hona-Doutkandi approach)	48	400	-
II	11	Gumti (Meghna loop approaching Dautkandi)	16	300	1.60
Total			317		28.40

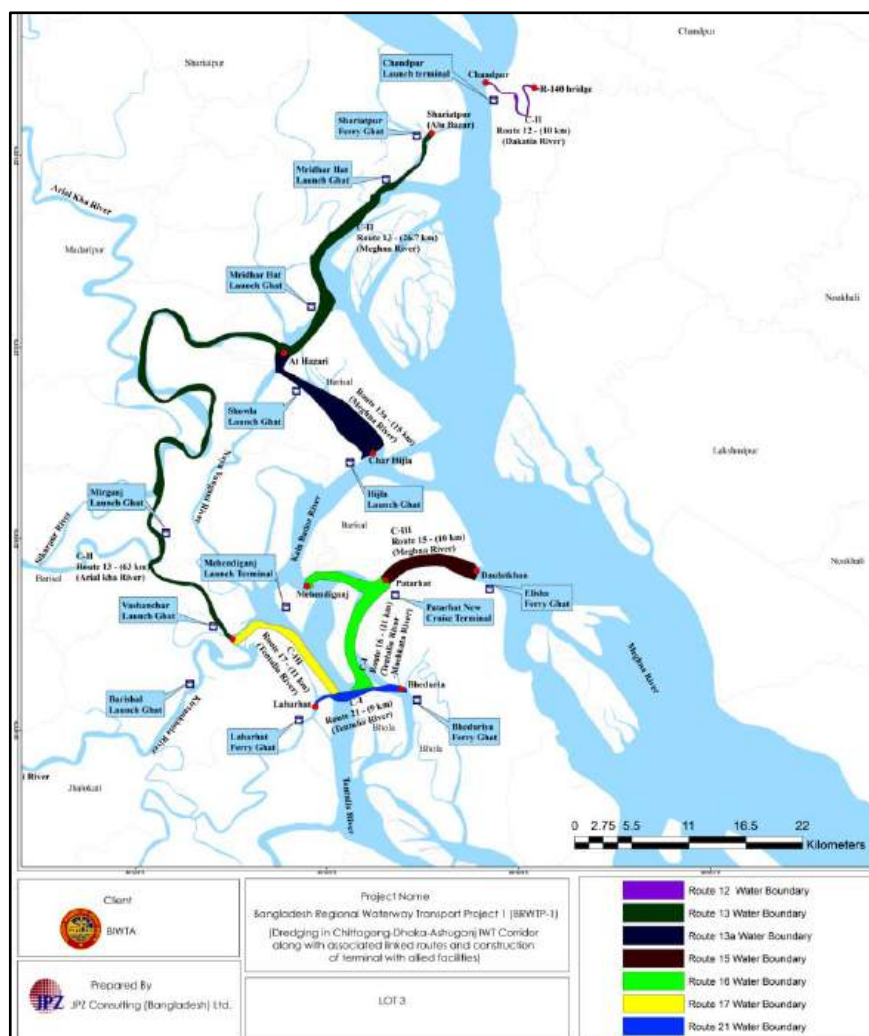
Figure 2: River Boundary, Lot-3

Class	Route No	River/location	Length (Km)	Average width (m)	Shoal Length (km)
II	12	Dakatia (Chandpur to Gastola Bridge)	10	400	-
II	13	Meghna and Arial Khan (Shariatpur-Bheduria)	89.7	1200	-
II	13a	Meghna (Looping root Inside Char Hisla)	15	850	-
III	15	Meghna/ Tentulia (Patarhat-Daulatkhan)	10	450	-
I	16	Meghna/Tentulia (Mehendiganj-Bheduria)	19.6	180	2.1
III	17	Tentulia (Bheduria -Bhashanchar)	11	400	-
I	21	Tentulia (Bheduria -Laharhat)	9	300	2.3
Total			164.3		4.4
