MONTHLY PROGRESS REPORT OCTOBER 2024

Consultancy Services for Supervision and Monitoring of Performance-Based Dredging
Contracts with Maintenance Dredging and Installation and Maintenance of Navigational Aids
along the Navigational Routes under the Contract

Bangladesh Regional Waterway Transport Project-1 BRWTP-S1A

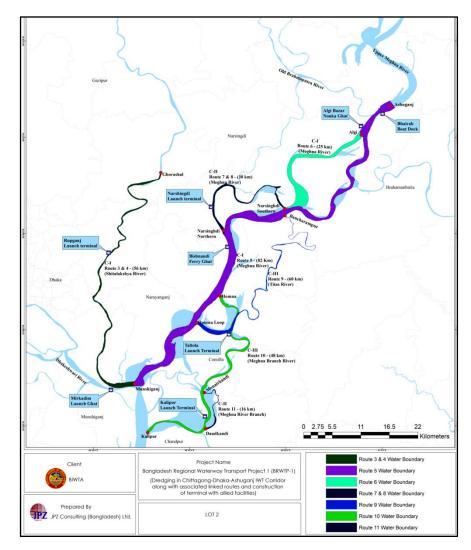
Figure 1: River Boundary Lot-2

Class	Route No	River/location	Length (Km)	Average width (m)	Shoal Length (km)
I	3 & 4	Shitalakshya (From Ghorashal to Munshiganj)	56	400	_
I	5	Meghna (From Ashuganj to Munshiganj)	82	1200	-
I	6	Meghna (Nabinagar Loop joining Route-5)	25	850	1.5
II	7 & 8	Meghna (Narsingdi Northern & Southern approaches)	30	450	5.8
III	III 9 Meghna (Bancharampur - Homna Loop)		60	180	19.5
III	10	Meghna (Hona-Doudkandi approach)	48	400	-
II	11	Gumti (Meghna loop approaching Dautkandi)	16	300	1.60
		Total	317		28.40

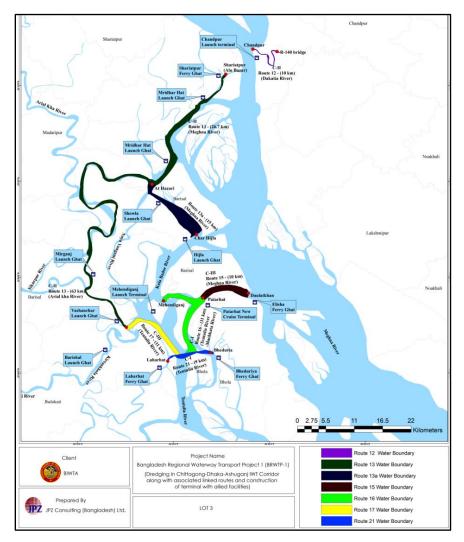
Figure 2: River Boundary, Lot-3

Class	Route No	River/location	Length (Km)	Average width (m)	Shoal Length (km)
II	12	Dakatia (Chandpur to Gastola Bridge)	10	400	-
II	13	Meghna and Arial Khan (Shariatpur-Bheduria)	89.7	1200	-
II	13a	Meghna (Looping root Inside Char Hisla)	15	850	-
III	15	Meghna/ Tentulia (Patarhat-Daulatkhan)	10	450	-
I	16	Meghna/Tentulia (Mehendiganj-Bheduria)	19.6	180	2.1
III	17	Tentulia (Bheduria -Bhashanchar)	11	400	-
I	21	Tentulia (Bheduria -Laharhat)	9	300	2.3
		Total	164.3		4.4
