Bangladesh Inland Water Transport Authority (BIWTA)

MONTHLY PROGRESS REPORT FEBRUARY 2025

**Consultancy Services for Supervision and Monitoring of Performance-Based Dredging
Contracts with Maintenance Dredging and Installation and Maintenance of Navigational Aids
along the Navigational Routes under the Contract**

**Bangladesh Regional Waterway Transport Project-1
BRWTP-S1A**

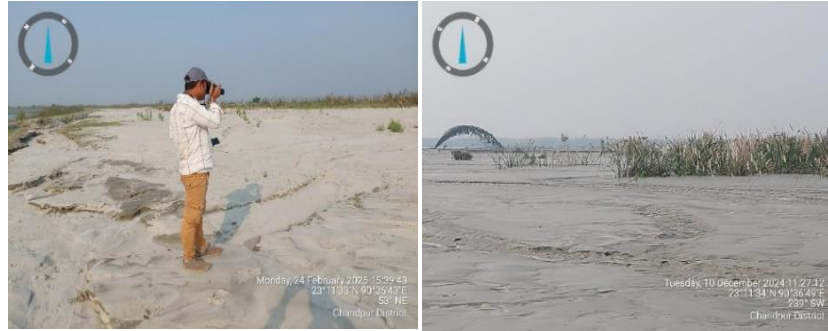
Figure 4: Condition of Dike No. 22 in February 2025 and in previous monitoring

No new dikes were observed this month, but the previously built Dike-22 near Eidgah Bazar Ferry Terminal on Route 13 was inspected. Situated on a fallow char land along the Meghna River, the dike showed no signs of harm to wildlife, fish mortality, or benthic disturbance.

Before the disposal of dredge material, the dike was covered with vegetation, dominated by reeds. Associated vegetation such as water hyacinth, taro, wild sugarcane, with additional species like pink morning glory and bushy mat grass. This site was a critical habitat for reed land but was converted to a dike without providing proper information to the S1A. A flock of Grey-headed Lapwing, Little Cormorant, and Black-headed Ibis were observed on the nearby mudflat.

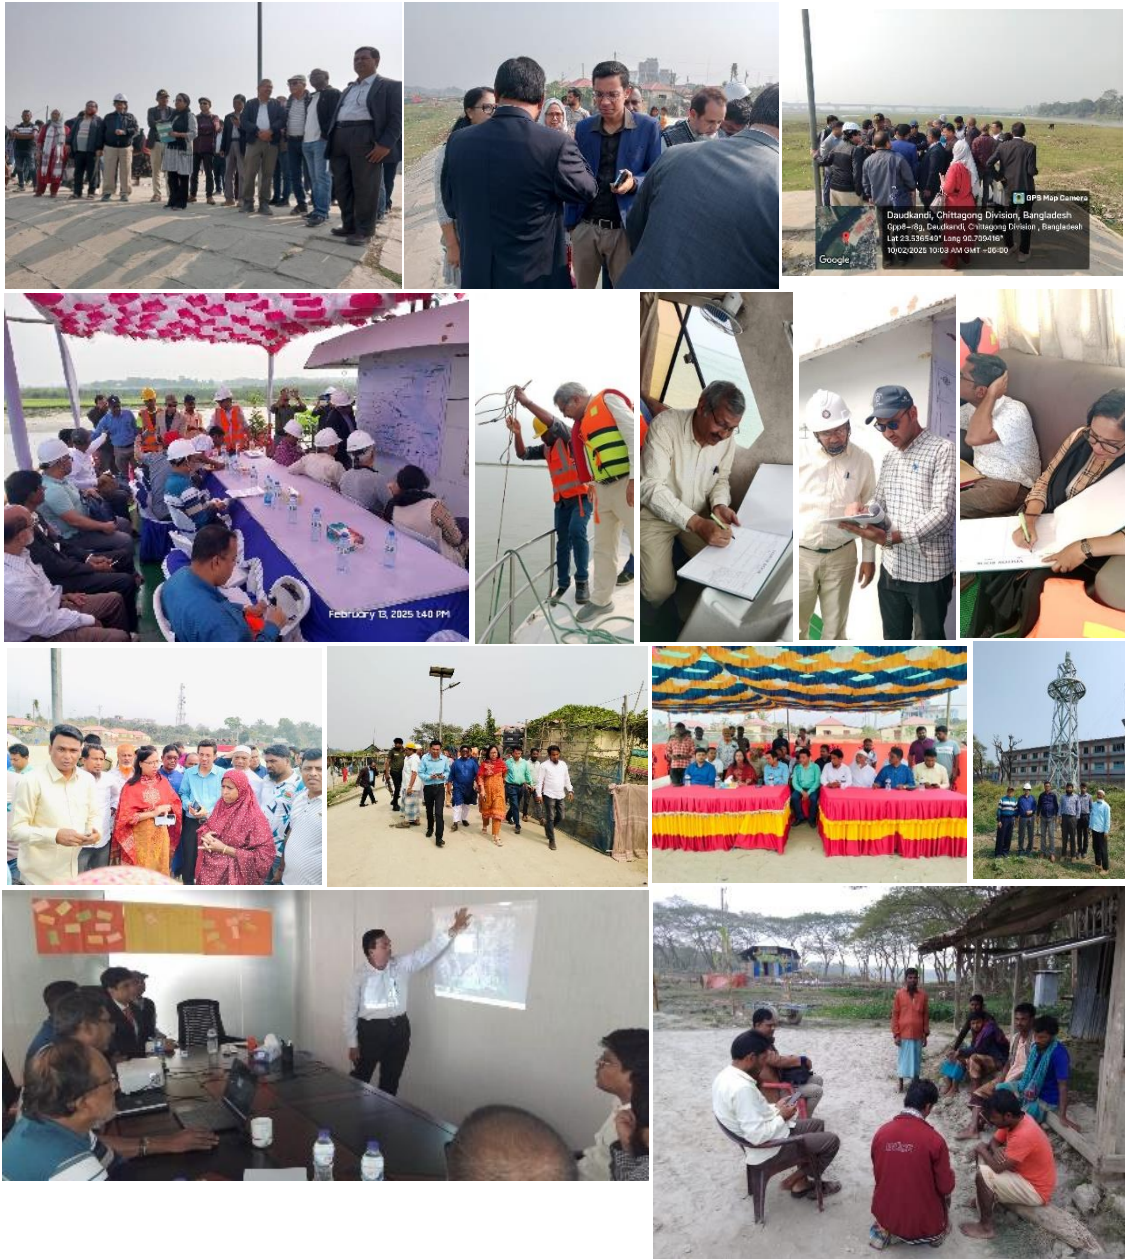
Progress Meetings, World Bank Mission, Field Visit, Communication, Consultation, Dike Selection, Preparation, ongoing Dredging, Survey, Fish, and Environmental Monitoring Sample Collection:
