Bangladesh Inland Water Transport Authority (BIWTA)

MONTHLY PROGRESS REPORT APRIL 2025

**Dredging Contracts with Maintenance Dredging and Installation and Maintenance
of Navigational Aids along the Navigational Routes under the Contract**

**Bangladesh Regional Waterway Transport Project-1
BRWTP-S1A**

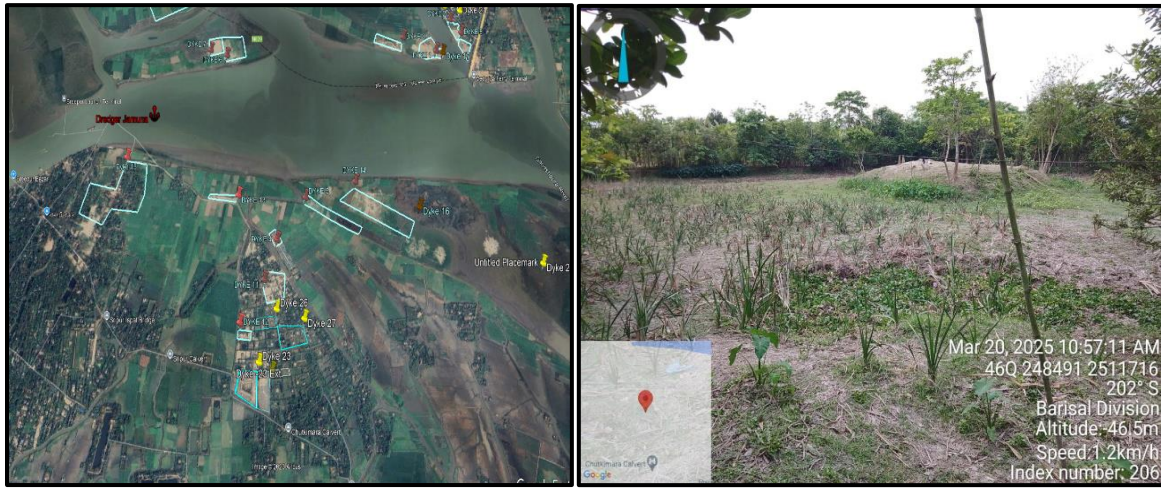
Figure 3: Photo of dredge material disposal area (ID-R21-D26)

Disposal Area	Northing	Easting	Area (approx.)	Height (approx.)	Contain Capacity	Land Type	Distance from RB	Location
R21-D26	2511711	248380	5376 m ²	1.5 m	8064 m ³	non-cultivable fallow land	800m offset.	Sreepur, Mehandiganj. Barisal
	2511662	248377						
	2511670	248498						
	2511716	248493						
R21-D27	2511672	248510	13125 m ²	1 m	13125 m ³	non-cultivable fallow land	800m offset	Sreepur, Mehandiganj. Barisal
	2511670	248654						
	2511599	248679						
	2511573	248524						
			18,501 m²		21,189 m³
